The Bearing Axial Cracks
Root Cause Hypothesis of

Frictional Surface Crack Initiation
and Corrosion Fatigue Driven Crack Growth

Presented at the NREL 2011 Wind Turbine Tribology Seminar, Broomfield/CO

Presented by Jürgen Gegner and Wolfgang Nierlich

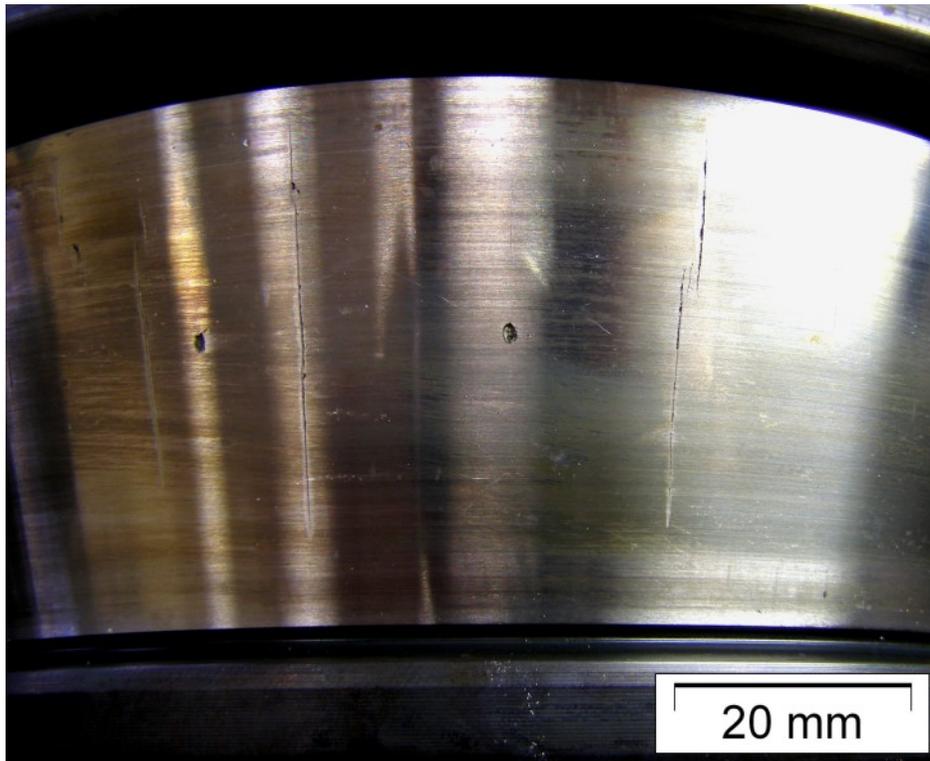
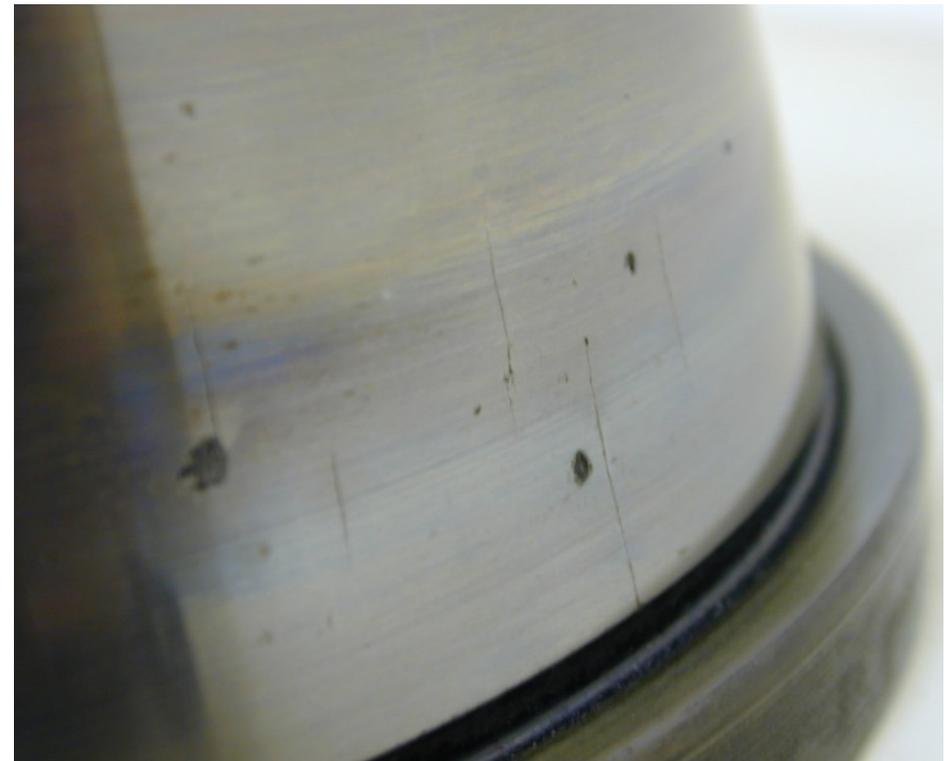
Visual Failure Pattern

axial raceway cracks of <1 mm to >20 mm length

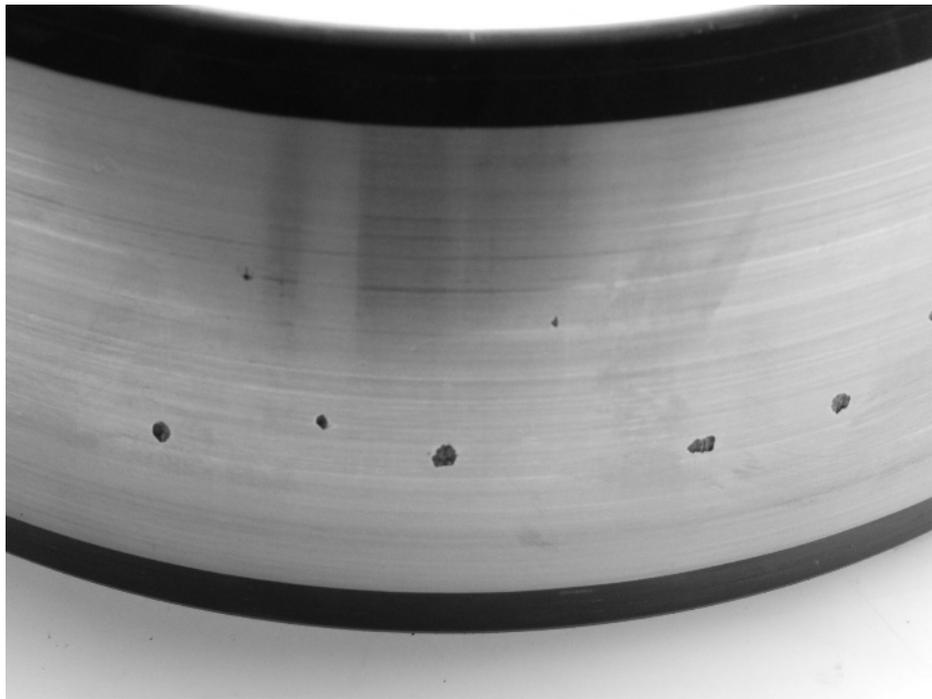
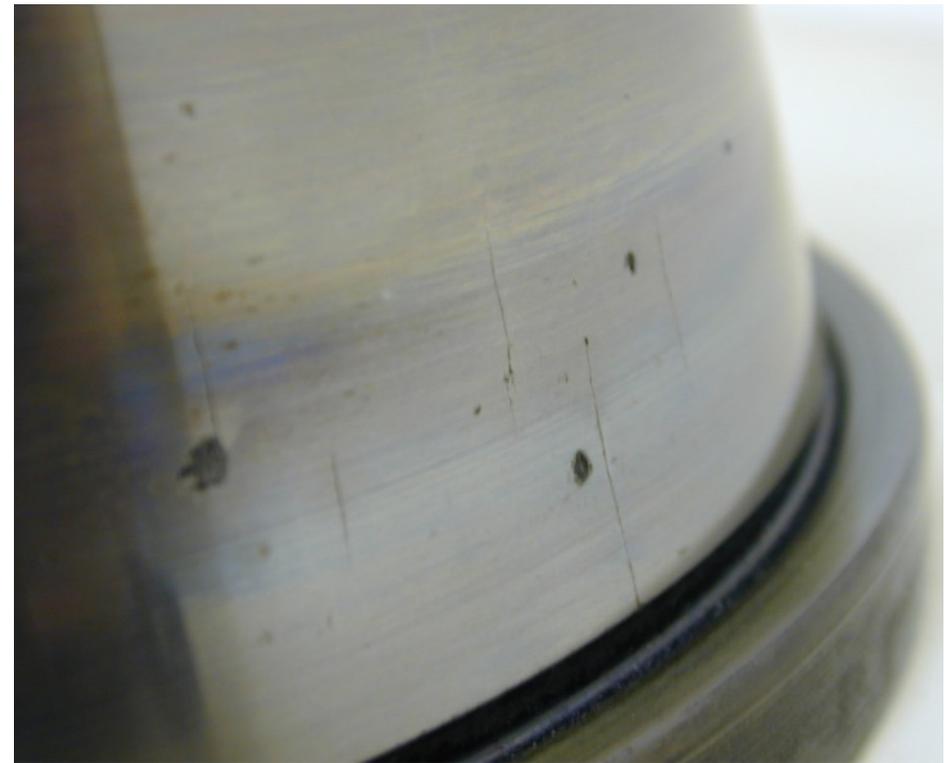
Visual Failure Pattern

axial raceway cracks of <1 mm to >20 mm length
Y partly with shell-shaped spallings

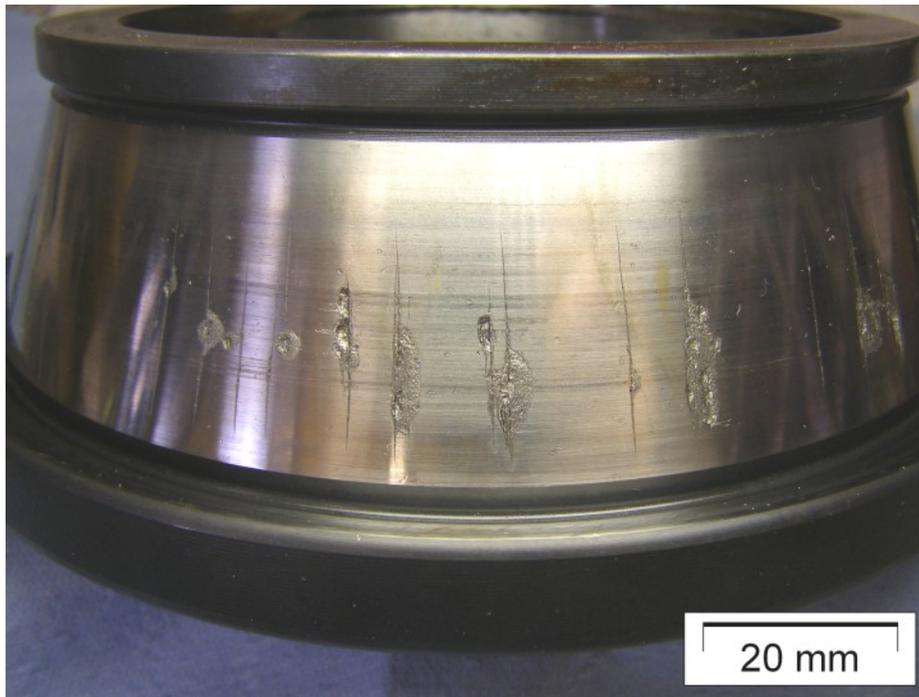
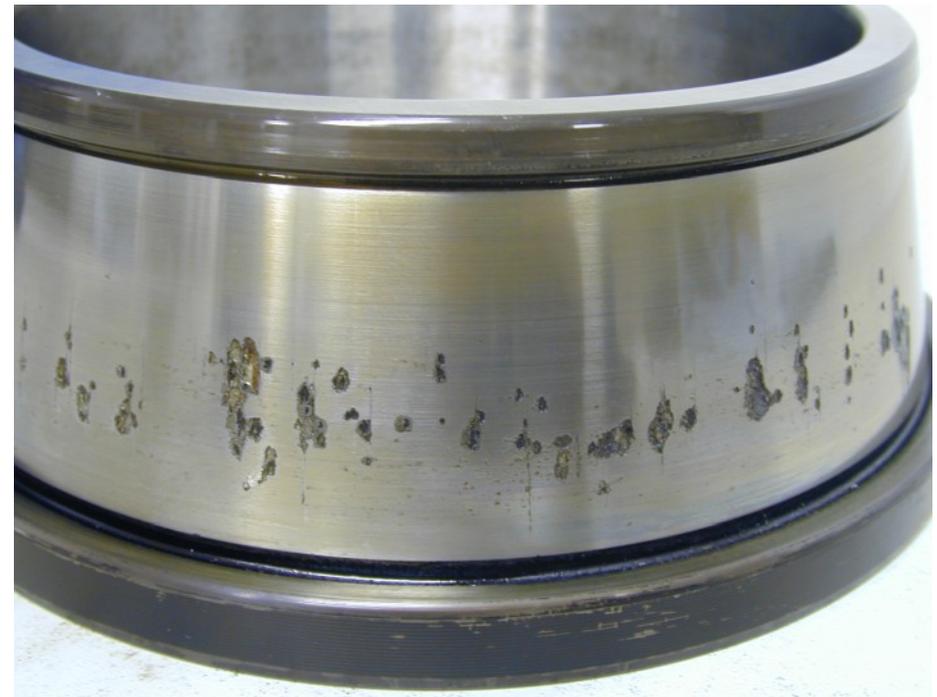
Visual Failure Pattern

axial raceway cracks of <1 mm to >20 mm length

• partly with shell-shaped spallings

• ... to advanced spallings

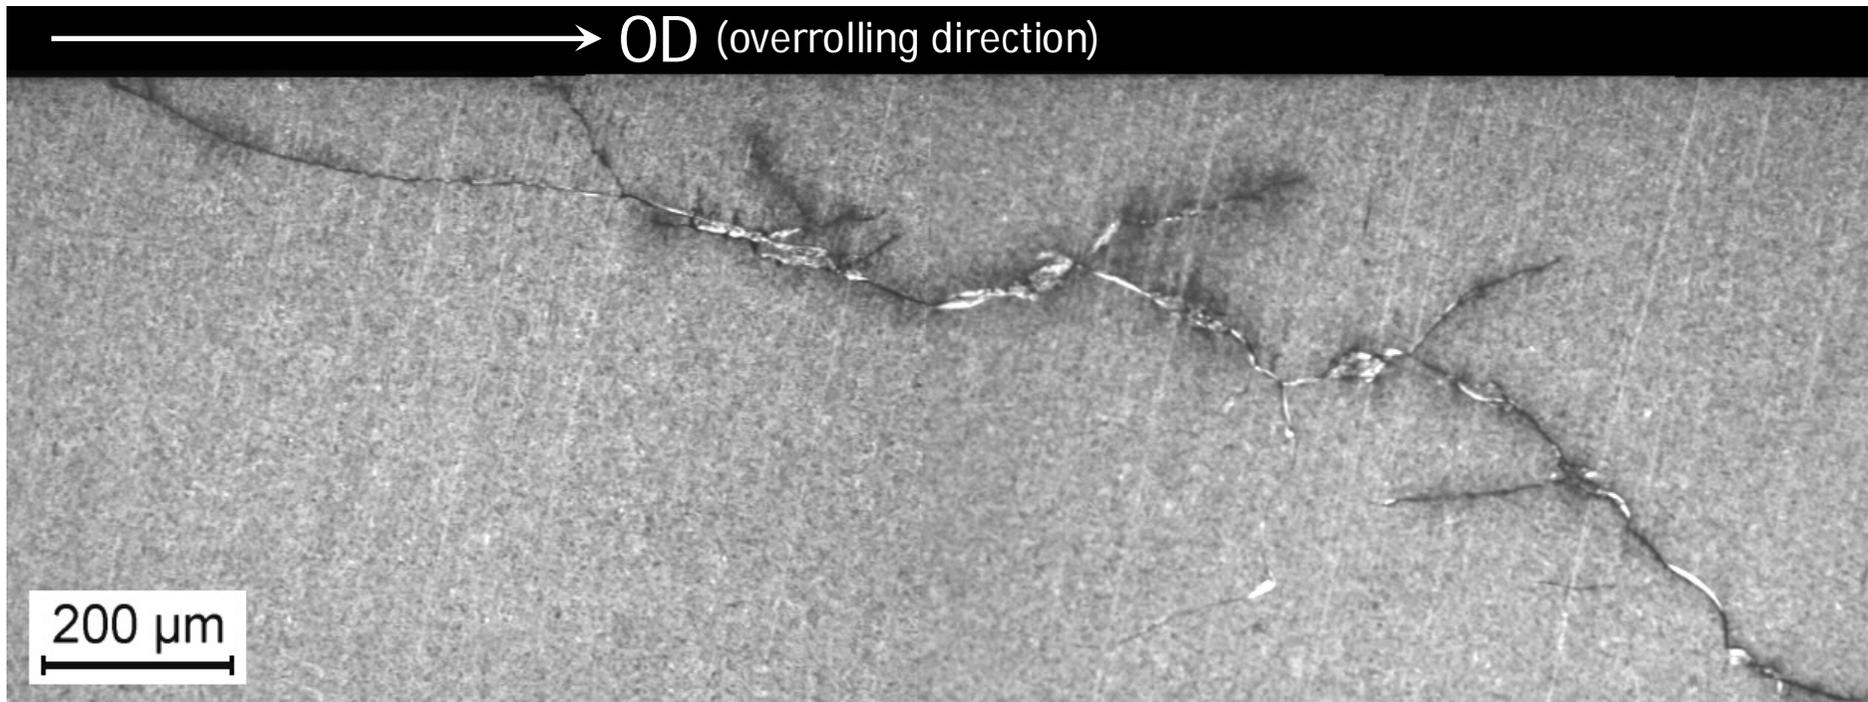
case hardening – CARB

$\dot{\gamma}$ tends to spalling rather than through cracking

$\dot{\gamma}$ basically independent of heat treatment and bearing type

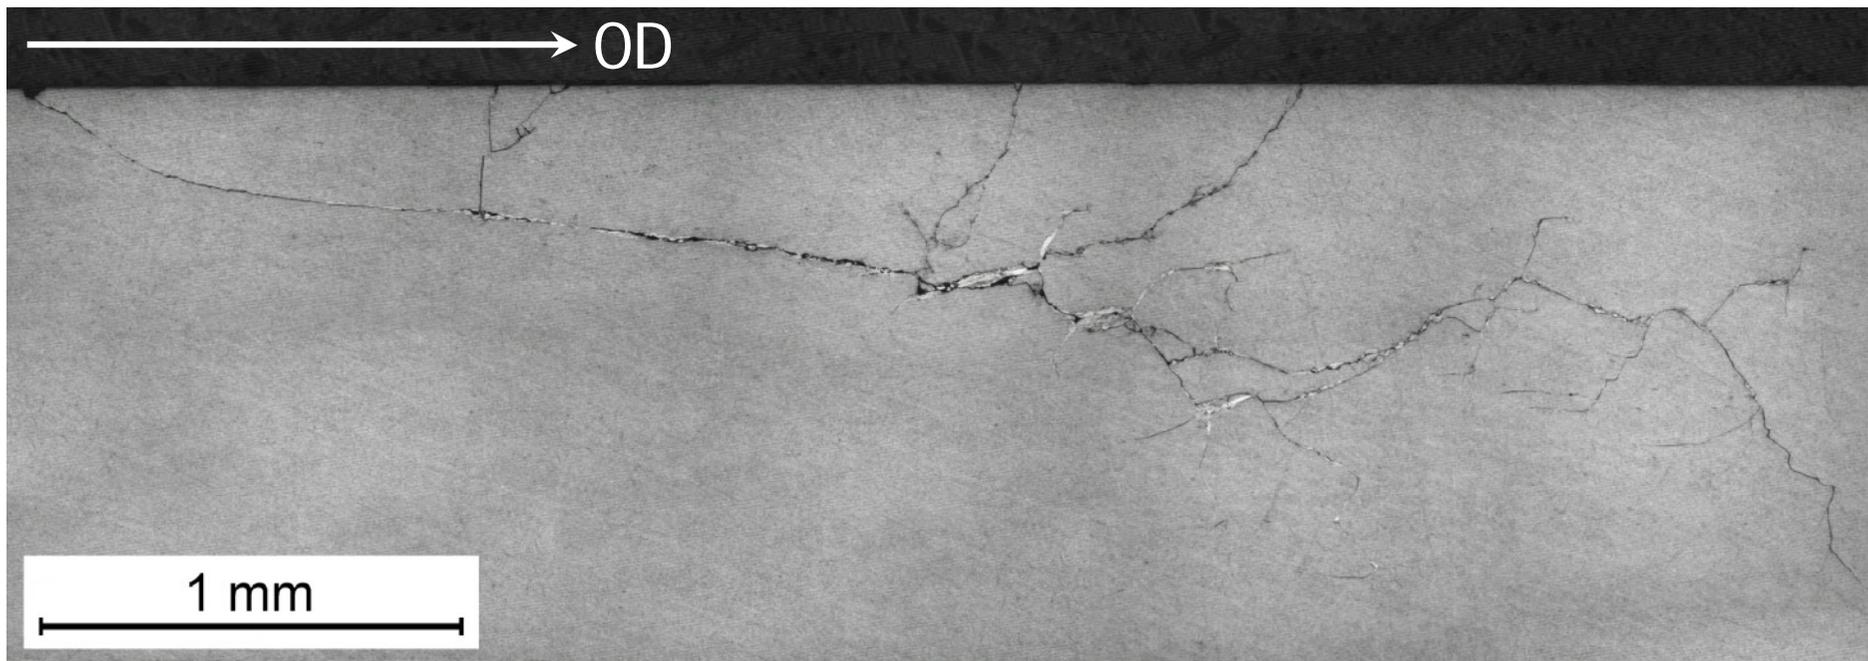
bainite hardening – SRB

$\dot{\gamma}$ tends to spalling rather than through cracking

$\dot{\gamma}$ basically independent of heat treatment and bearing type

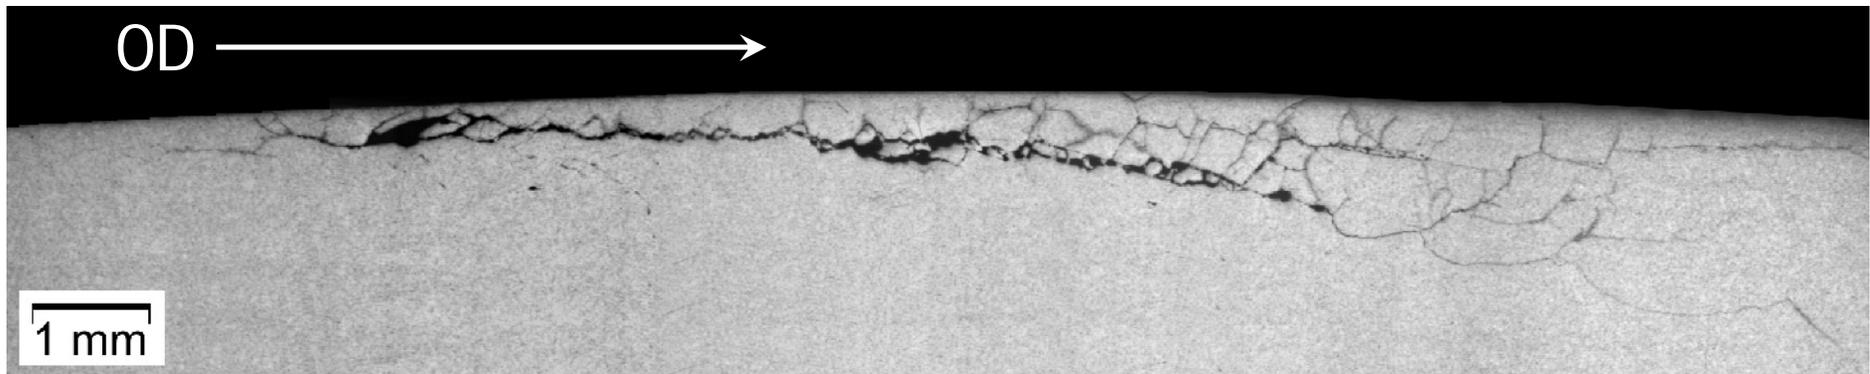
bainite hardening – CRB
ÿ development of the crack system on the raceway

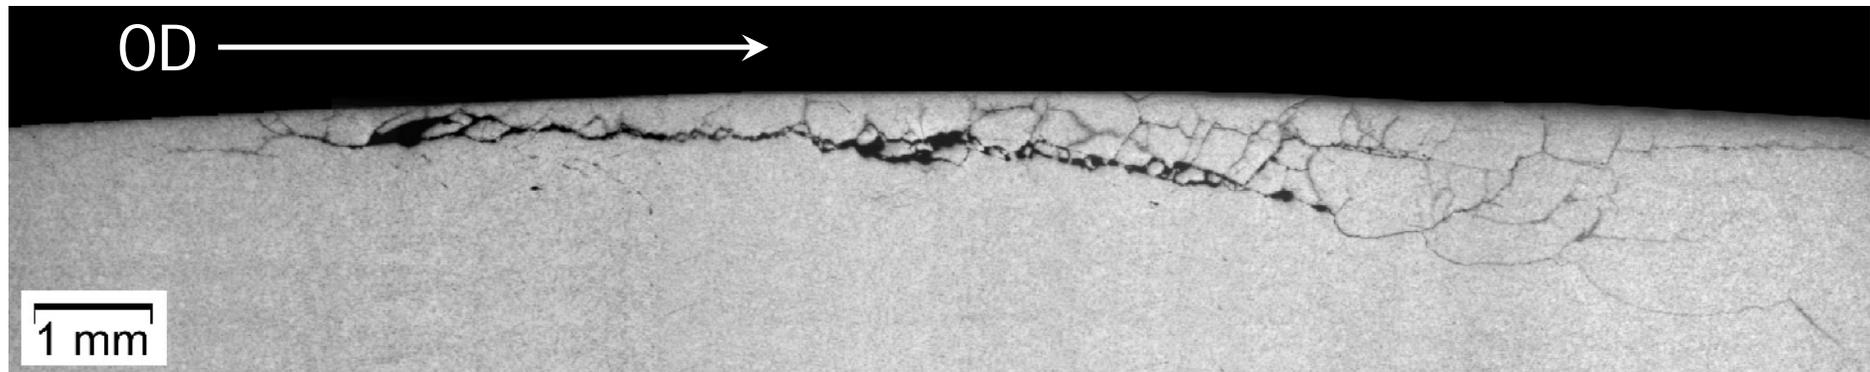
- bainite hardening – CRB
- development of the crack system on the raceway
- crack returns indicated

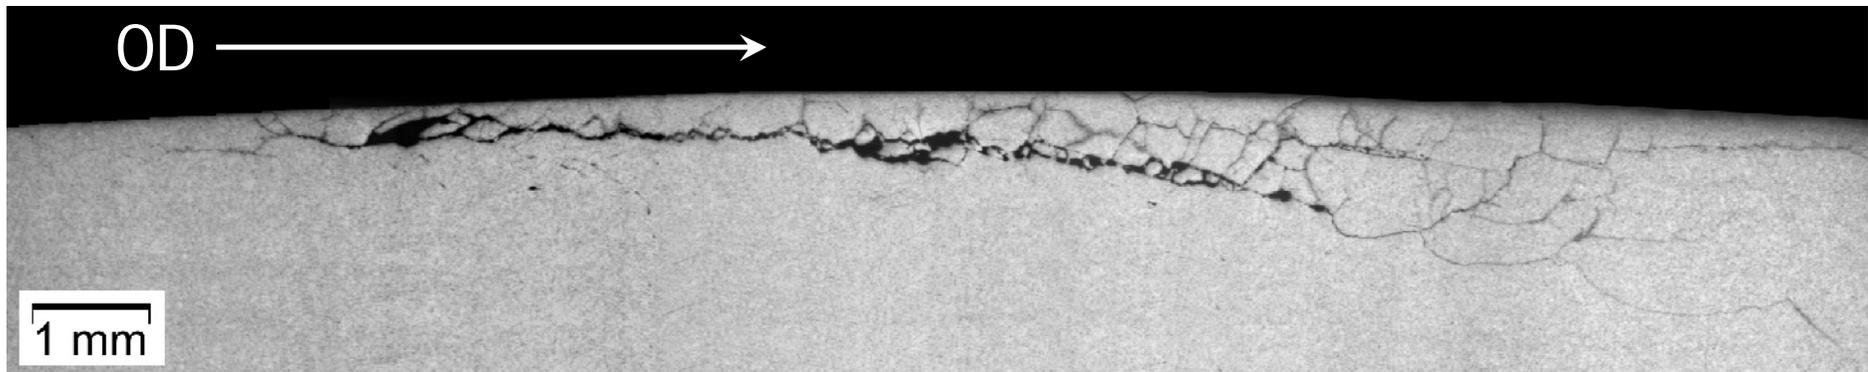
bainite hardening – CRB

• strongly branching & spreading deep transgranular crack systems at moderate permanent loads

• chemically assisted RCF \Rightarrow corrosion fatigue cracking (CFC)

• ... in overrolling direction \Rightarrow surface initiation indicated

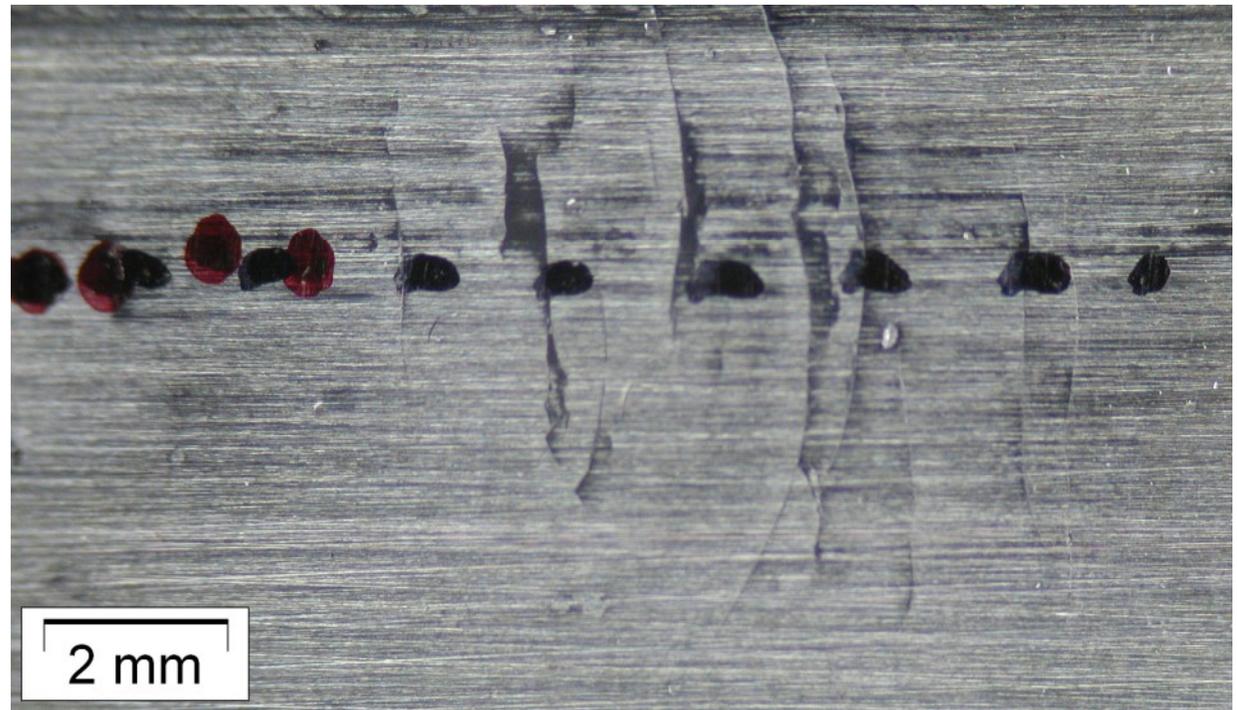
subsurface cracks tend to develop large fatigue spallings
when reaching the raceway surface

ÿ extended spalling-free crack systems not to be expected

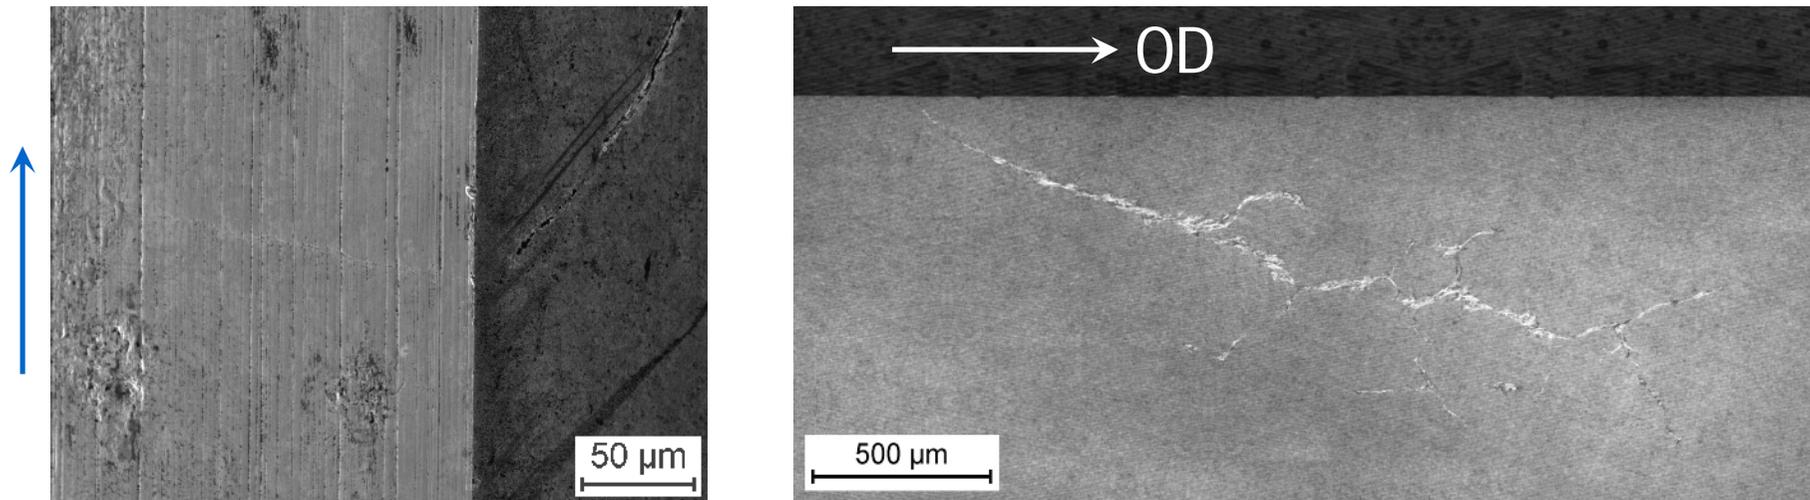
OD shows surface initiation – crack opened during preparation

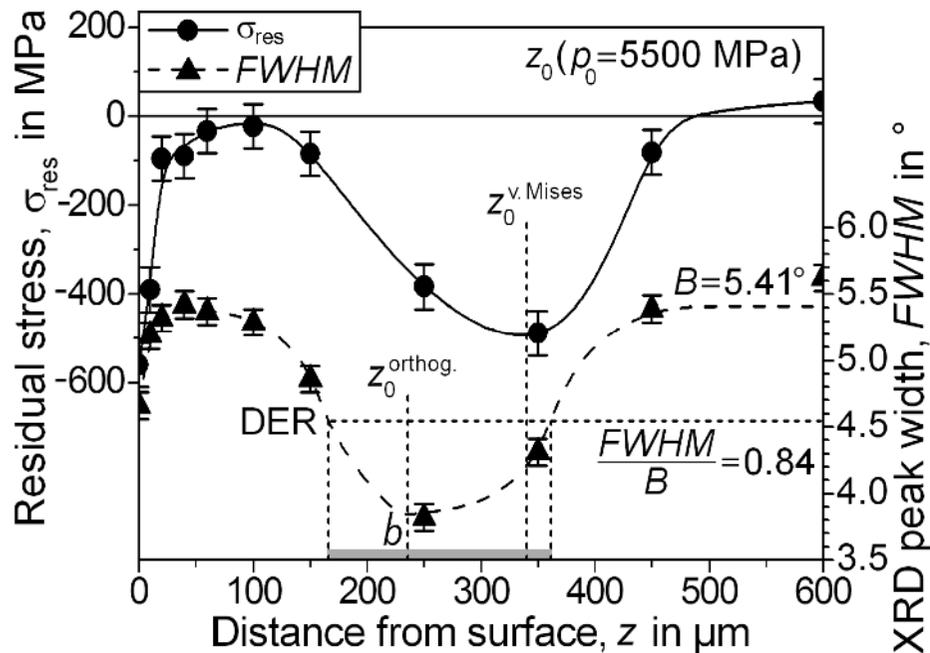
OR-DGBB from alternator rig

• H-RCF: SWB @ $b/B \approx 0.71$, microcracking

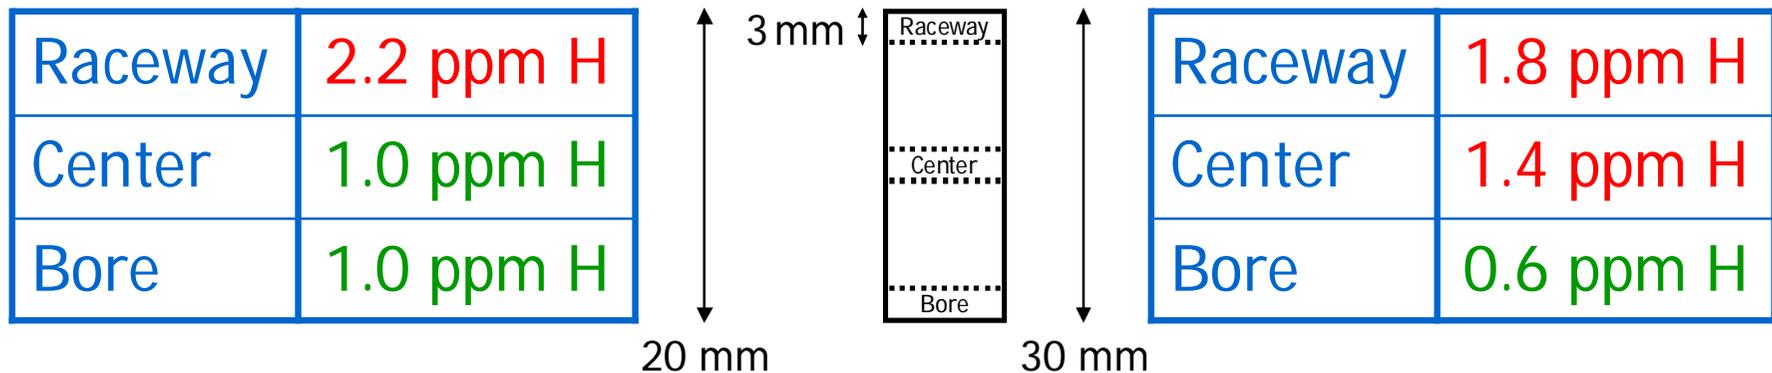
hydrogen absorption occurs rapidly not until raceway cracking

• $D_{\text{eff}} \approx 10^{-7} \text{ cm}^2/\text{s} \Rightarrow$ just several weeks to few months of inward diffusion after crack initiation and growth

• hydrogen released from aging products of penetrating lubricant

• intergranular hydrogen embrittlement of opened fracture faces is restricted to the forced rupture around original cracks

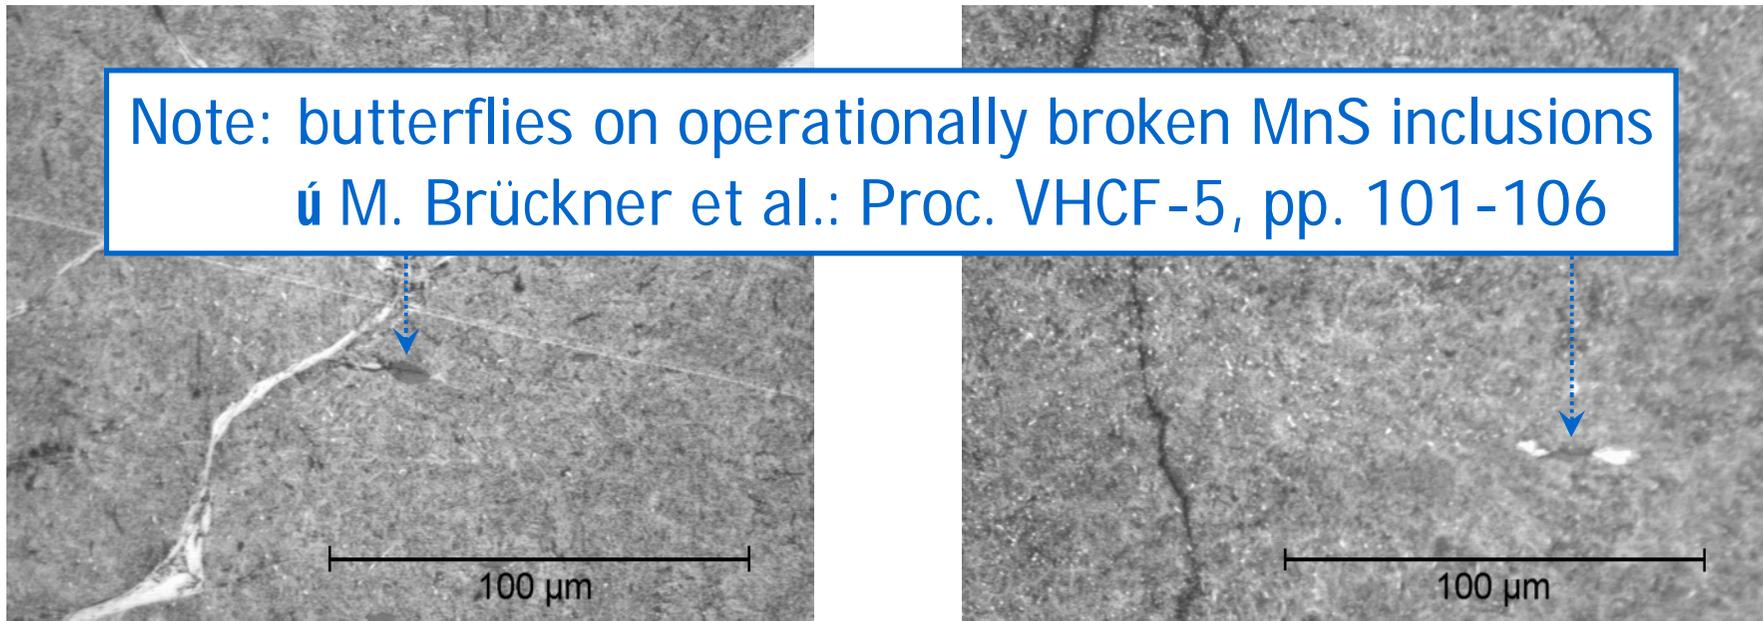
butterflies reveal no DER precursor structure of WEA formation

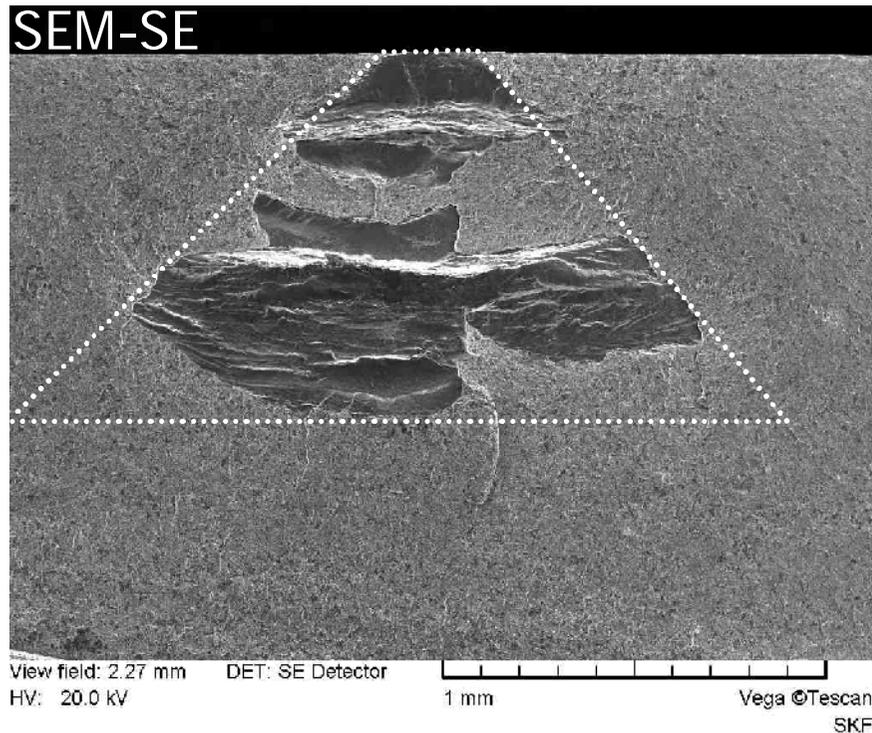
Small raceway crack

- original fracture surface clearly distinguishable
- **trapezoid shape** of the spreading crack reveals **top-down growth**

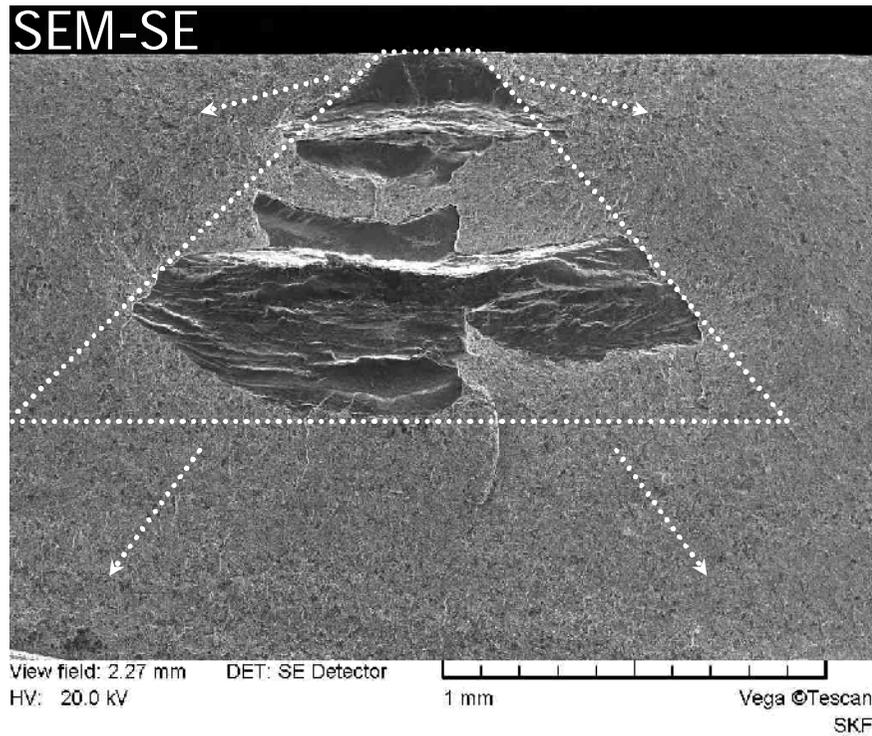
Small raceway crack

... further crack growth by corrosion fatigue

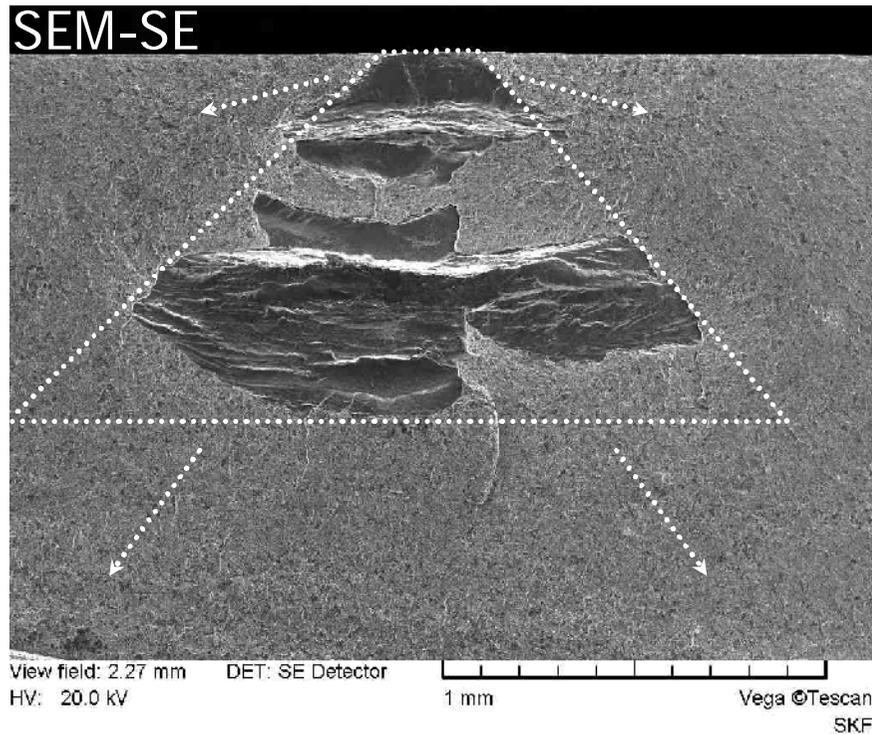
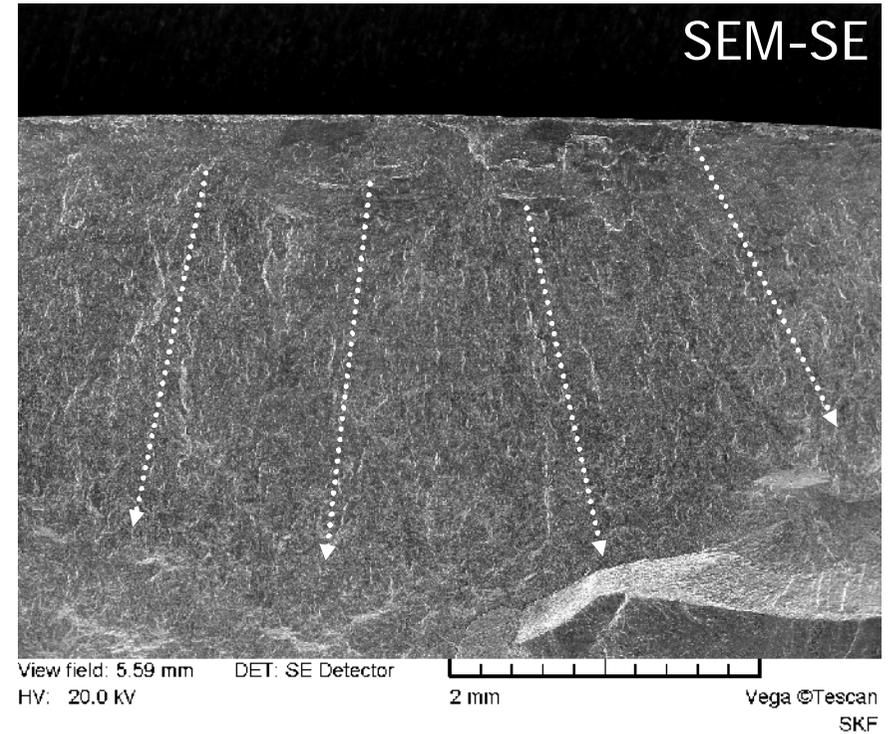
- radial propagation lines \Rightarrow top-down growth, surface initiation

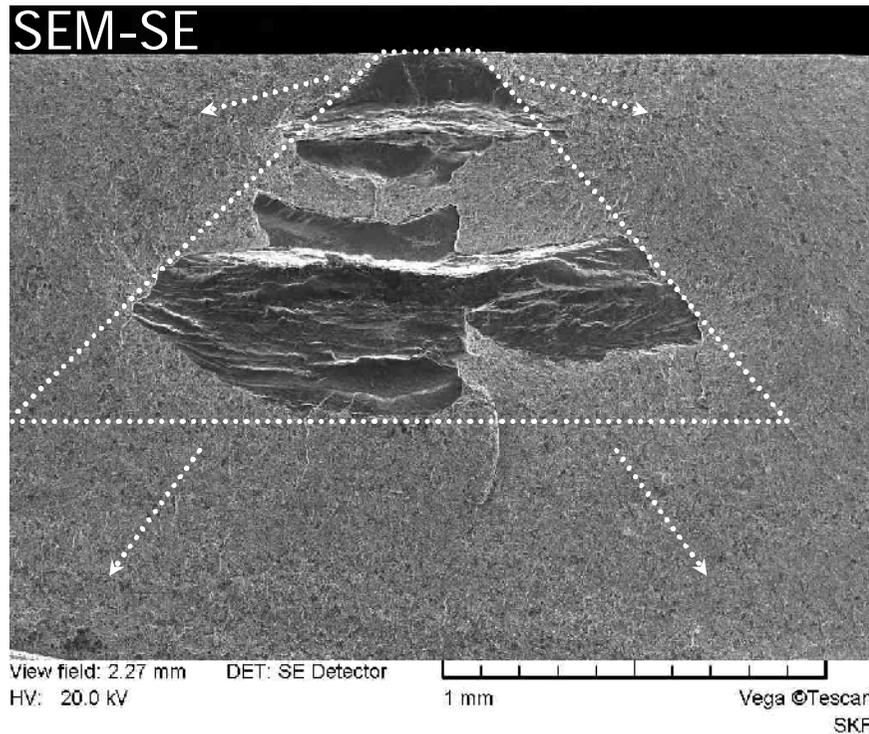
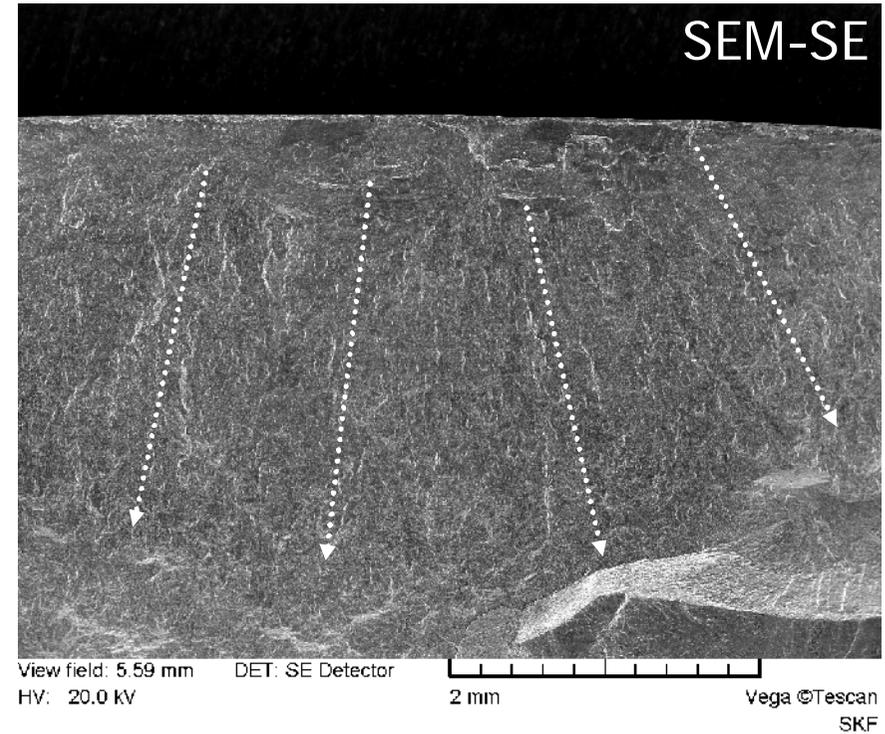
Description of the cracks

- step 1: cleavage-like fractures → normal stress hypothesis
 - step 2: corrosion fatigue cracking (CFC)
- microfractography, phase changes

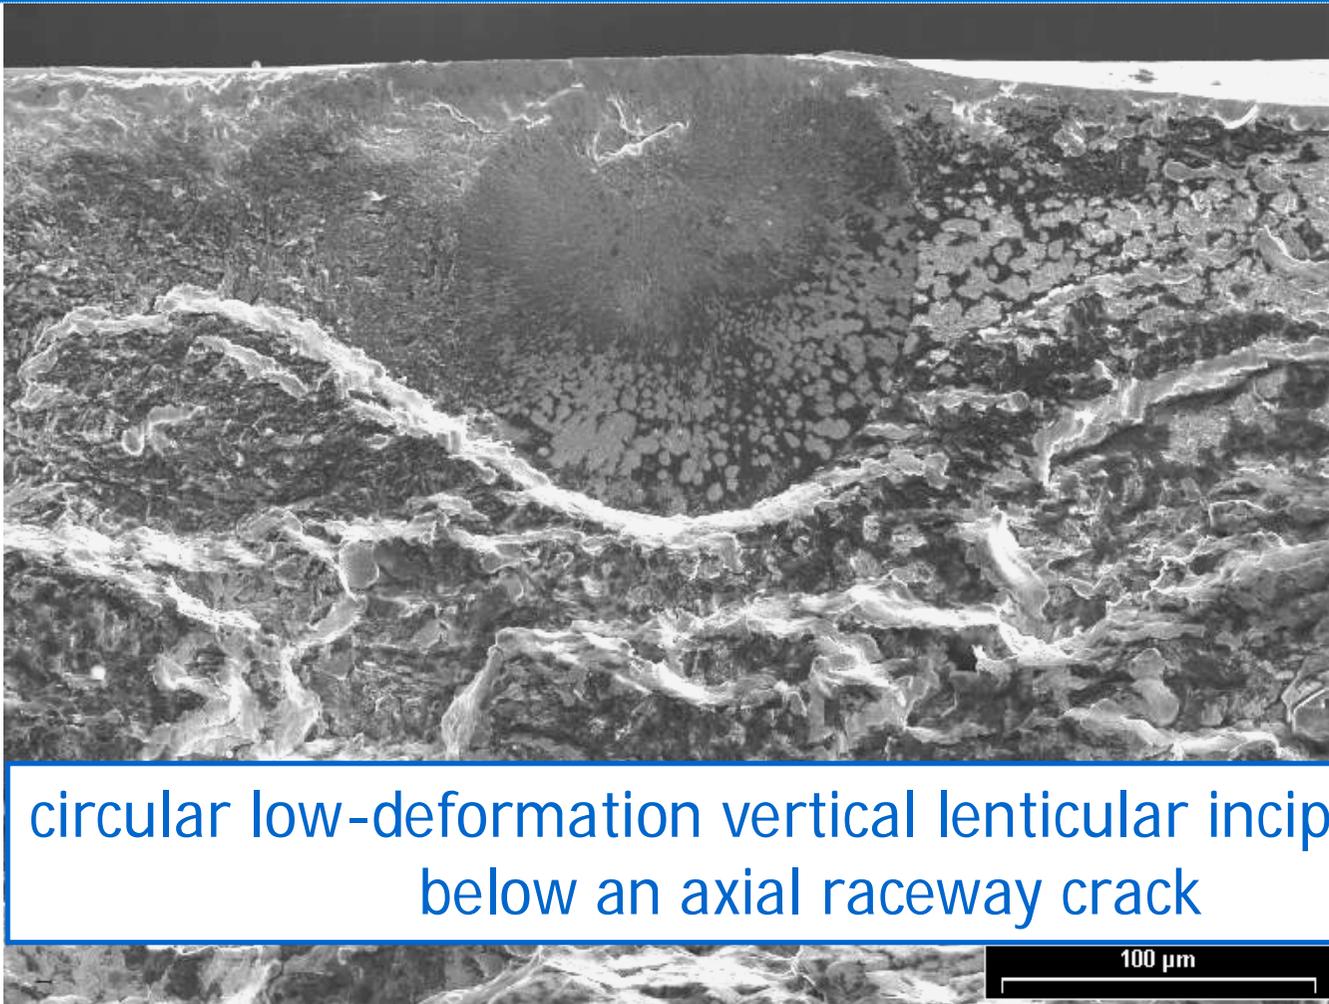
inhomogeneity:
inclusion
TiCN + MnS

circular low-deformation vertical lenticular incipient crack
below an axial raceway crack

cleavage fracture as initiation of CFC

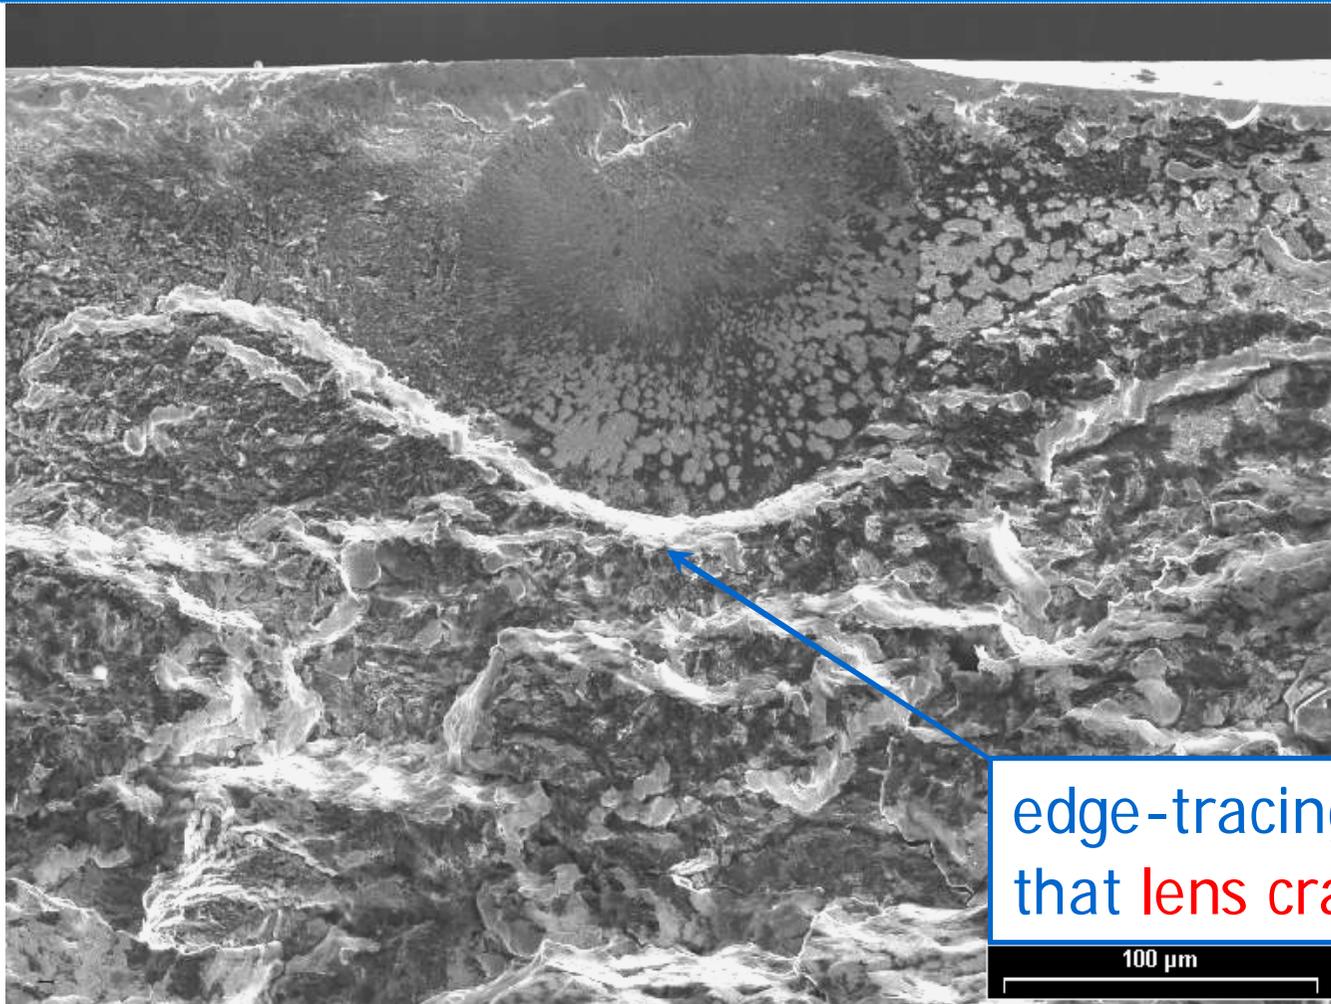
inhomogeneity:
inclusion
TiCN + MnS

edge-tracing bulge verifies
that lens crack occurs first

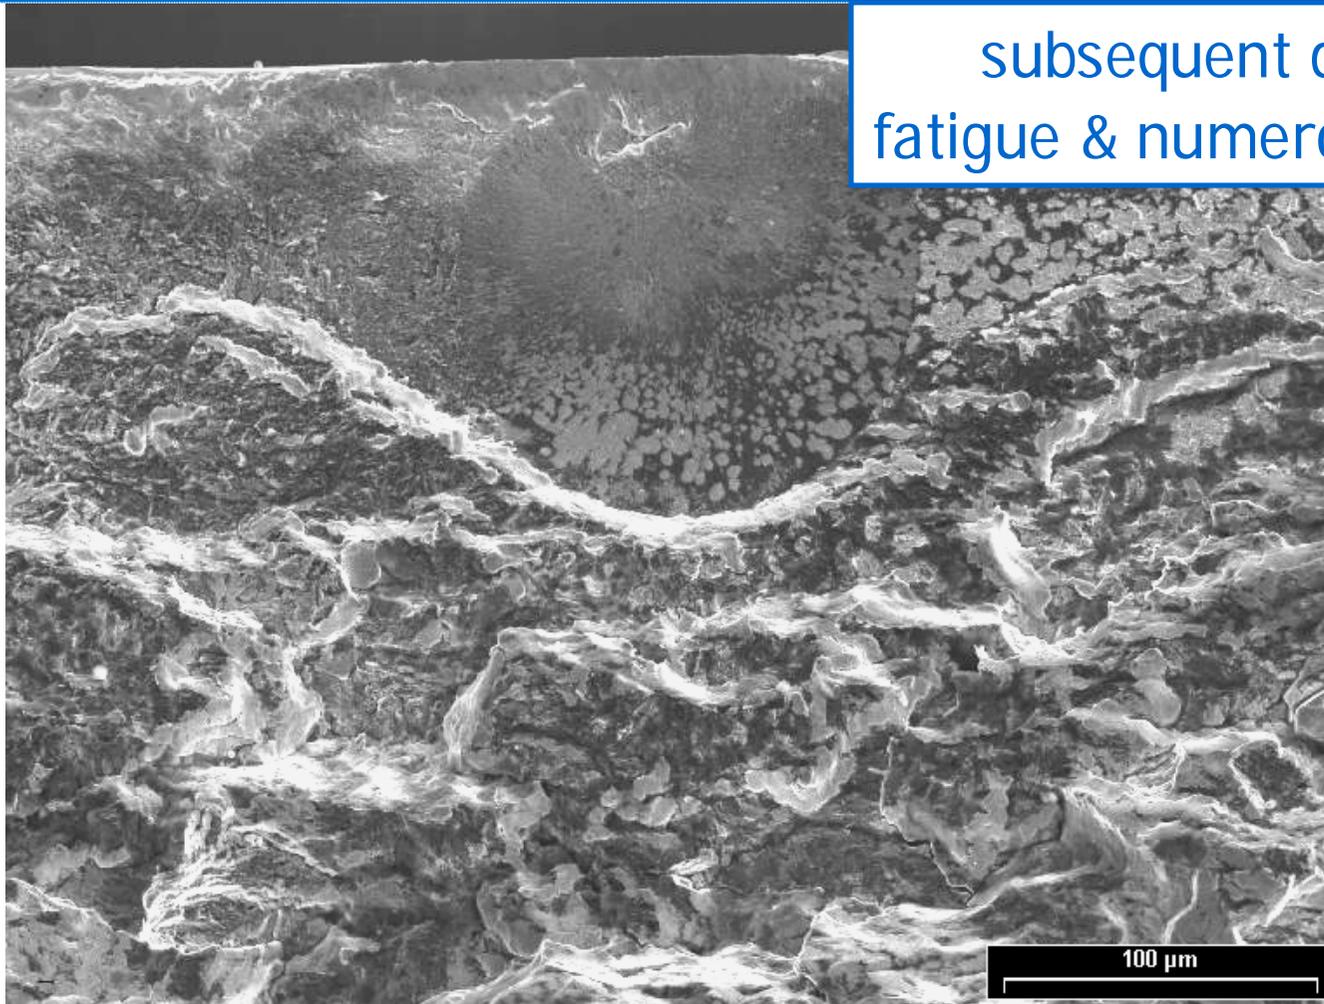
subsequent deep crack:
fatigue & numerous side cracks

inhomogeneity:
inclusion
TiCN + MnS

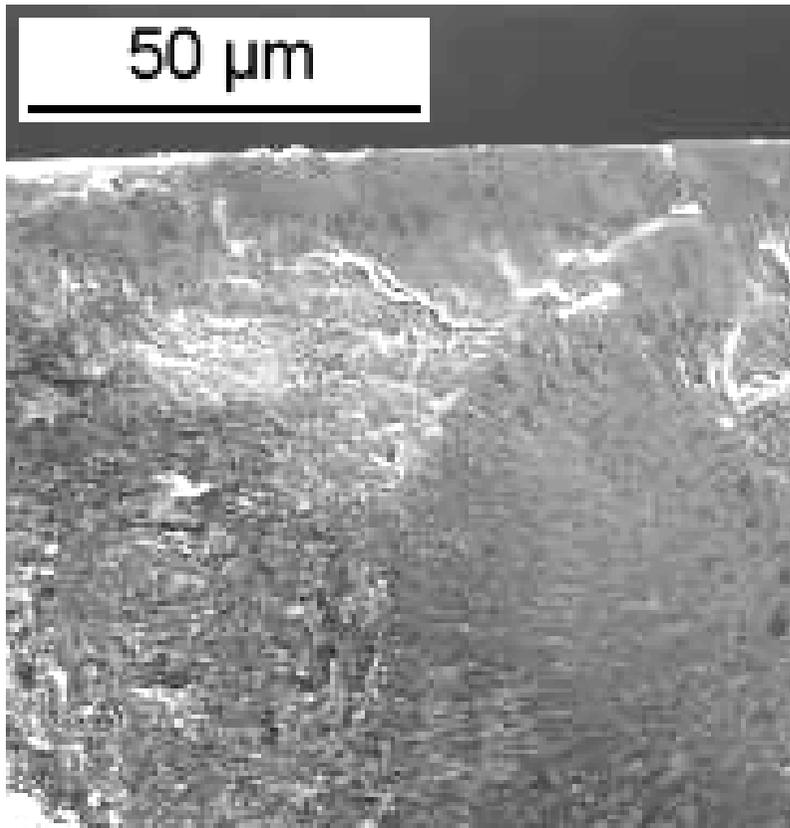
distinct change of the fracture pattern also on the left of the *lens*

fan structure on
cleavage area

faint side cracks
outside
