The Bearing Axial Cracks
Root Cause Hypothesis of

Frictional Surface Crack Initiation
and Corrosion Fatigue Driven Crack Growth

Presented at the NREL 2011 Wind Turbine Tribology Seminar, Broomfield/CO

Presented by Jürgen Gegner and Wolfgang Nierlich

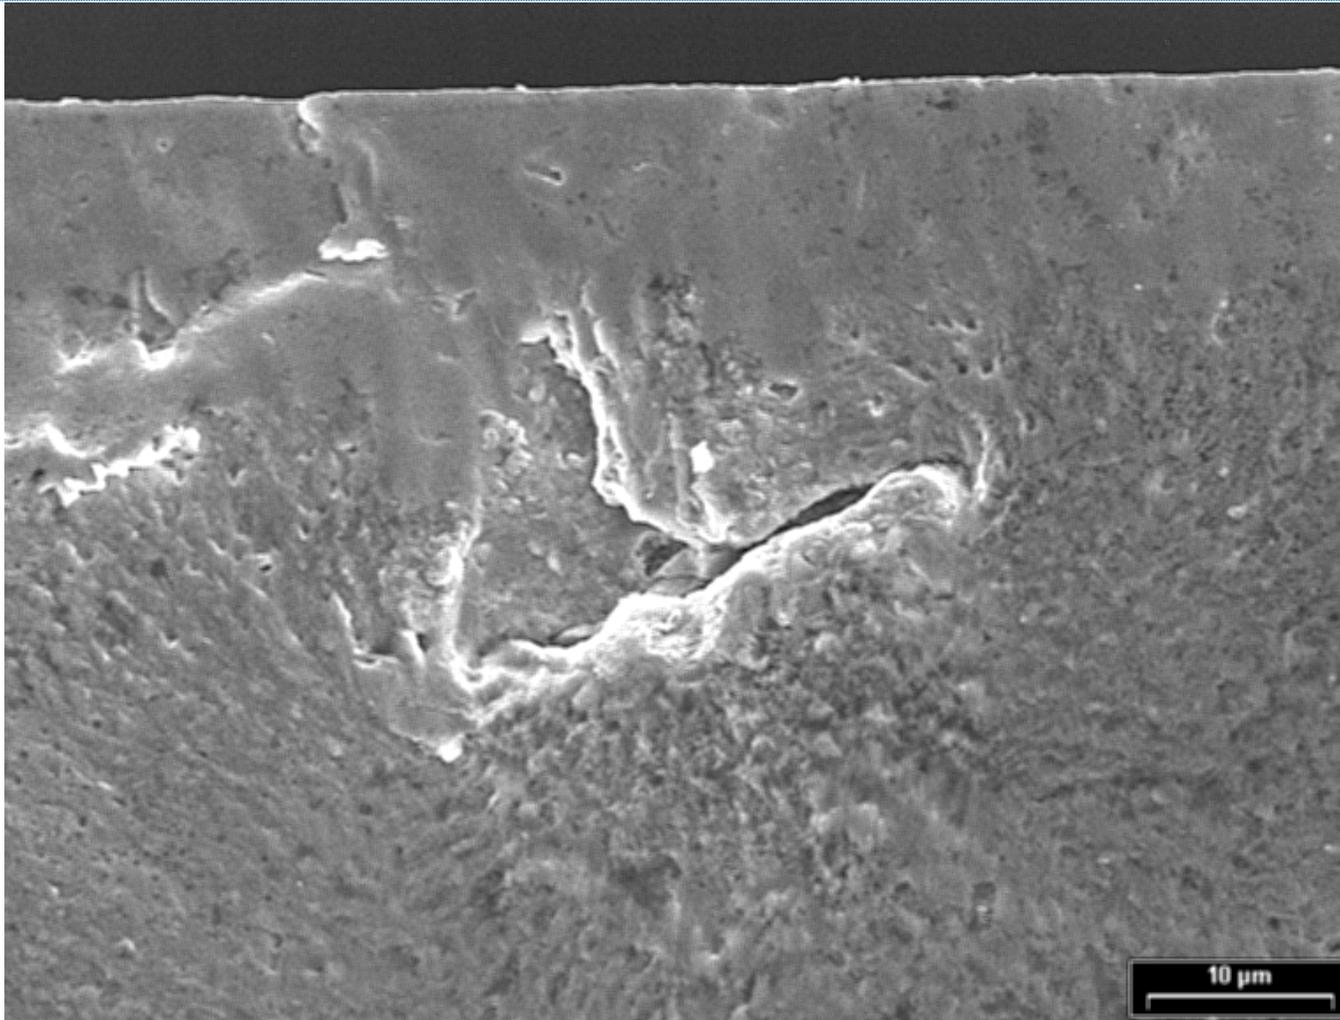
inclusion,
no butterfly

start of
fan structure

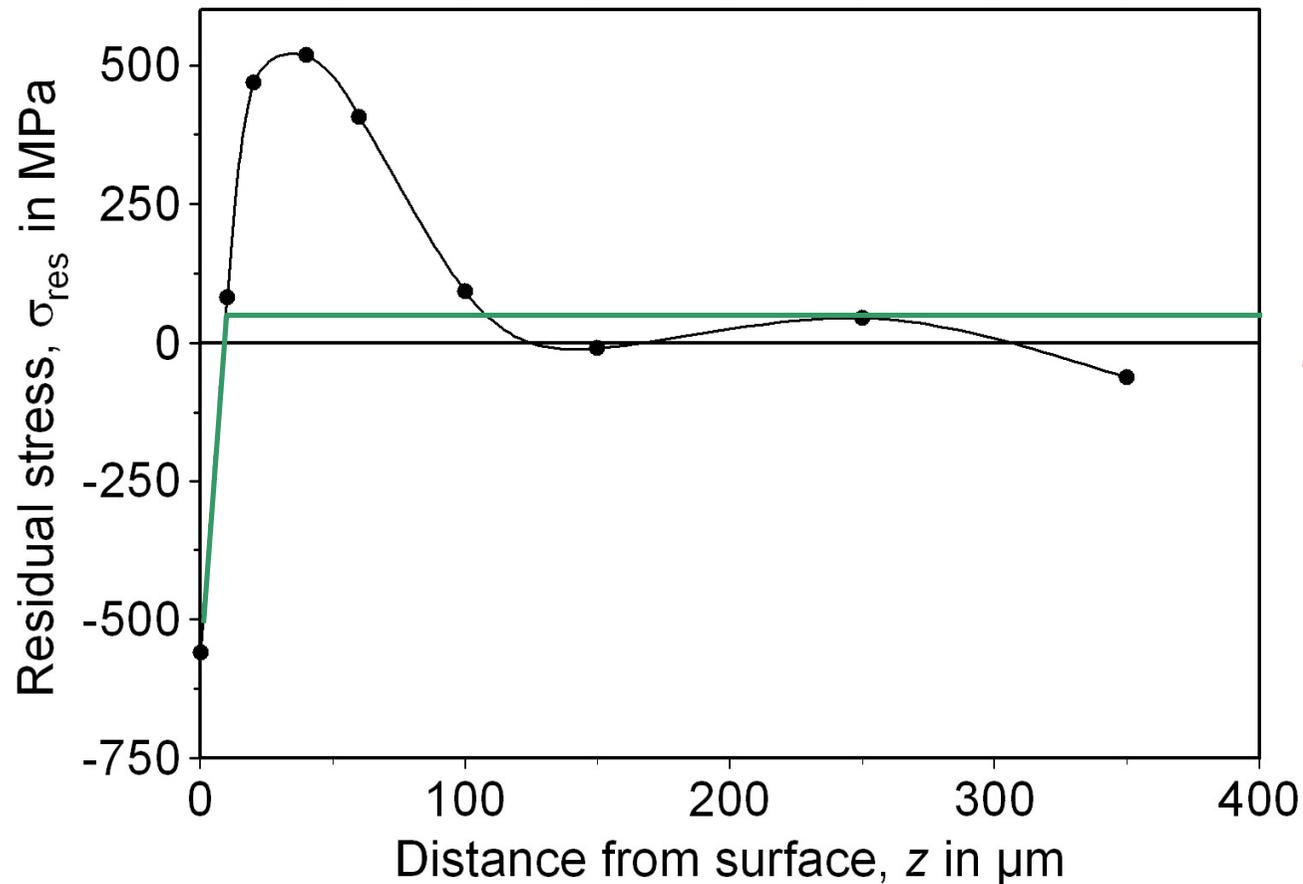
inhomogeneity:
near-surface
tensile residual stress

typical distribution
for martensitically
through hardened
and finished parts

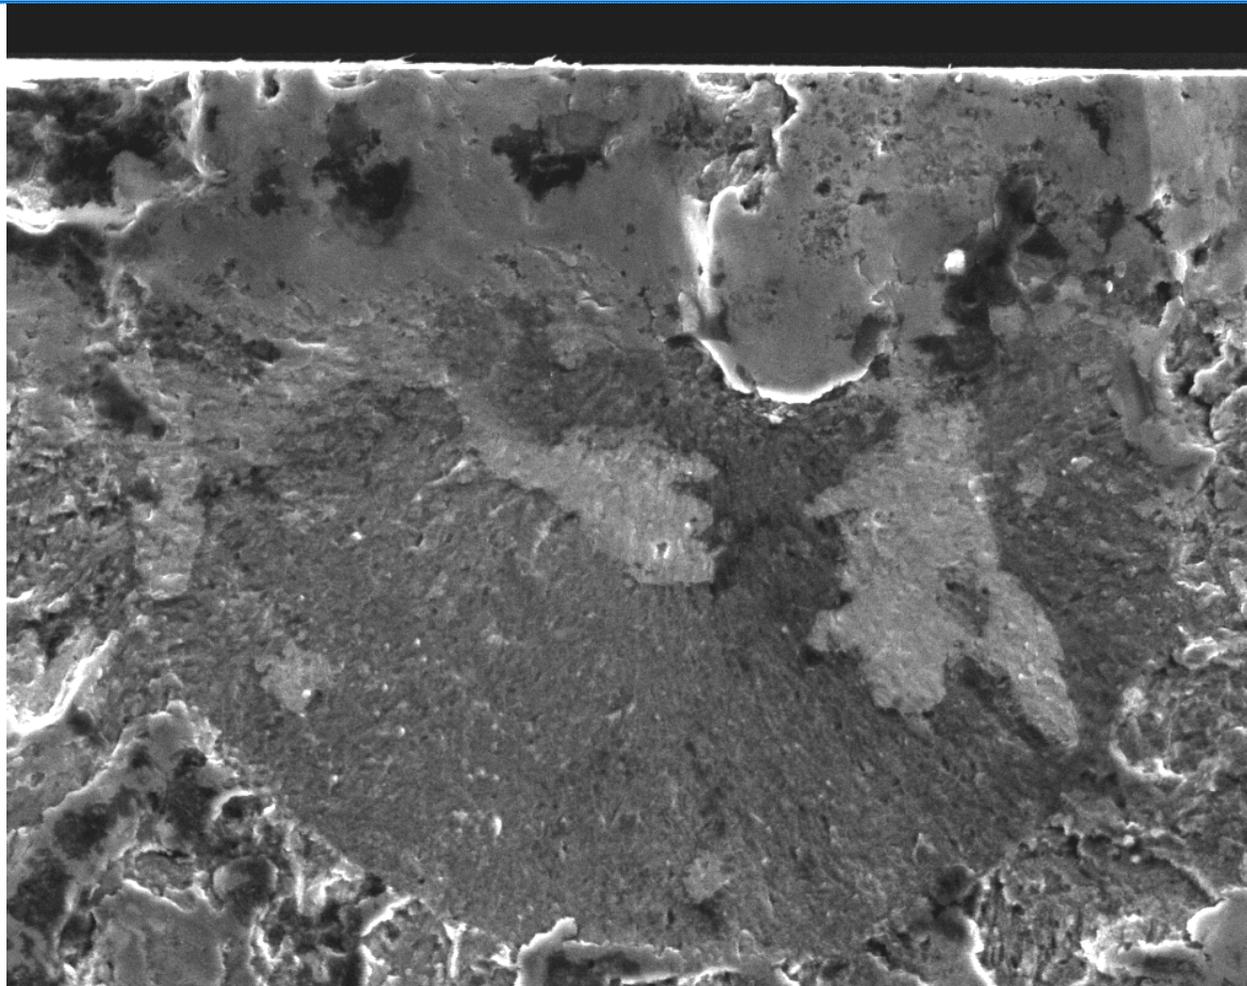
faint radial
fan structure

outside of *cleavage*:
side cracks,
martensite micro-
structure partly
visible

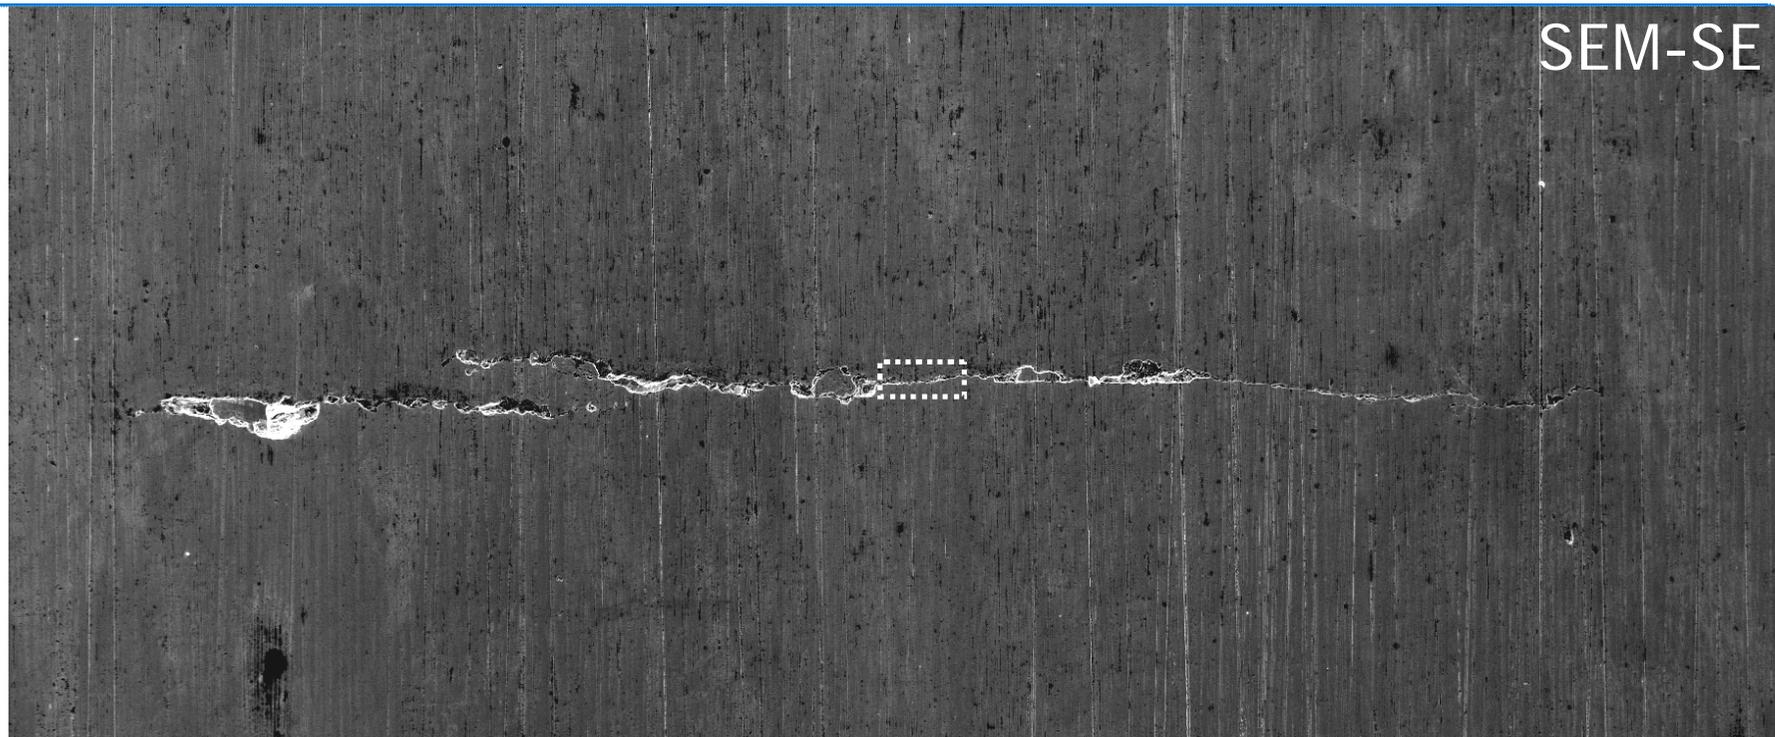
axial raceway crack

- distinctly smoothed honing structure \Rightarrow mixed friction conditions
- brittle spontaneous incipient crack below sharp-edged segment
- clearly distinguishable from adjacent serrated branching CFC

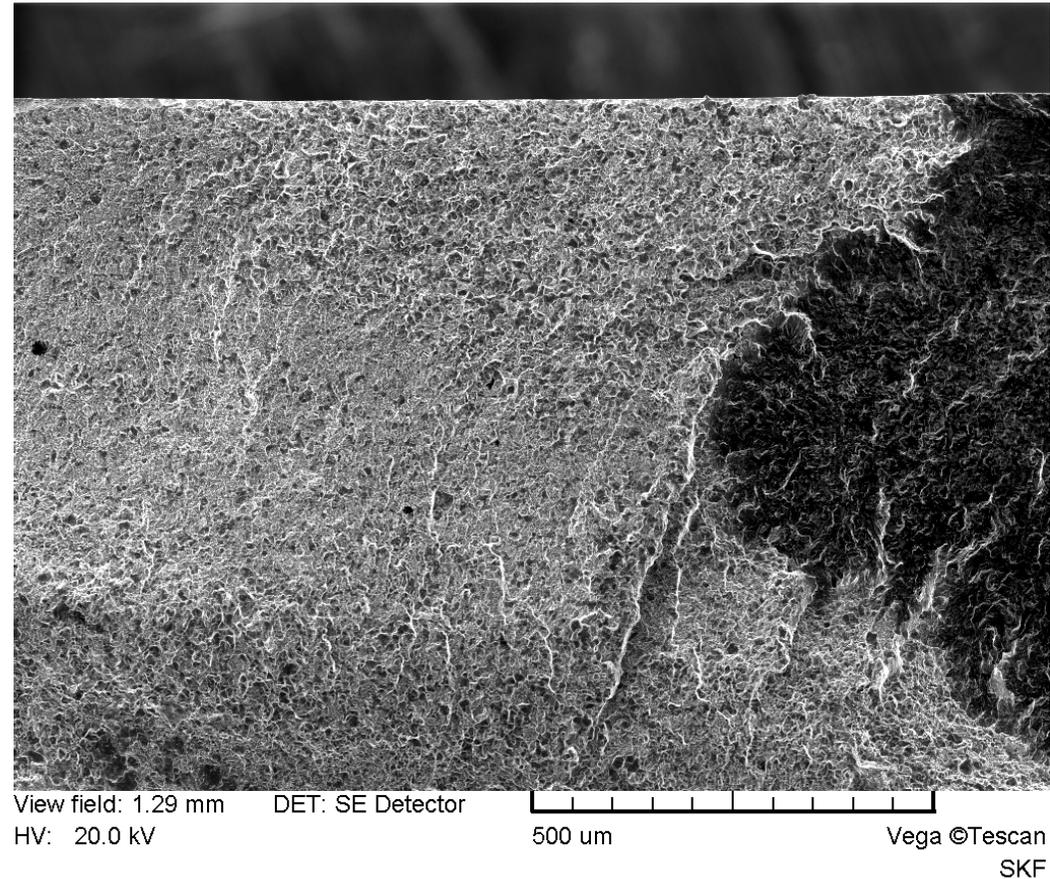
preparatively generated forced fracture face reveals local hydrogen embrittlement adjacent to the original CFC crack

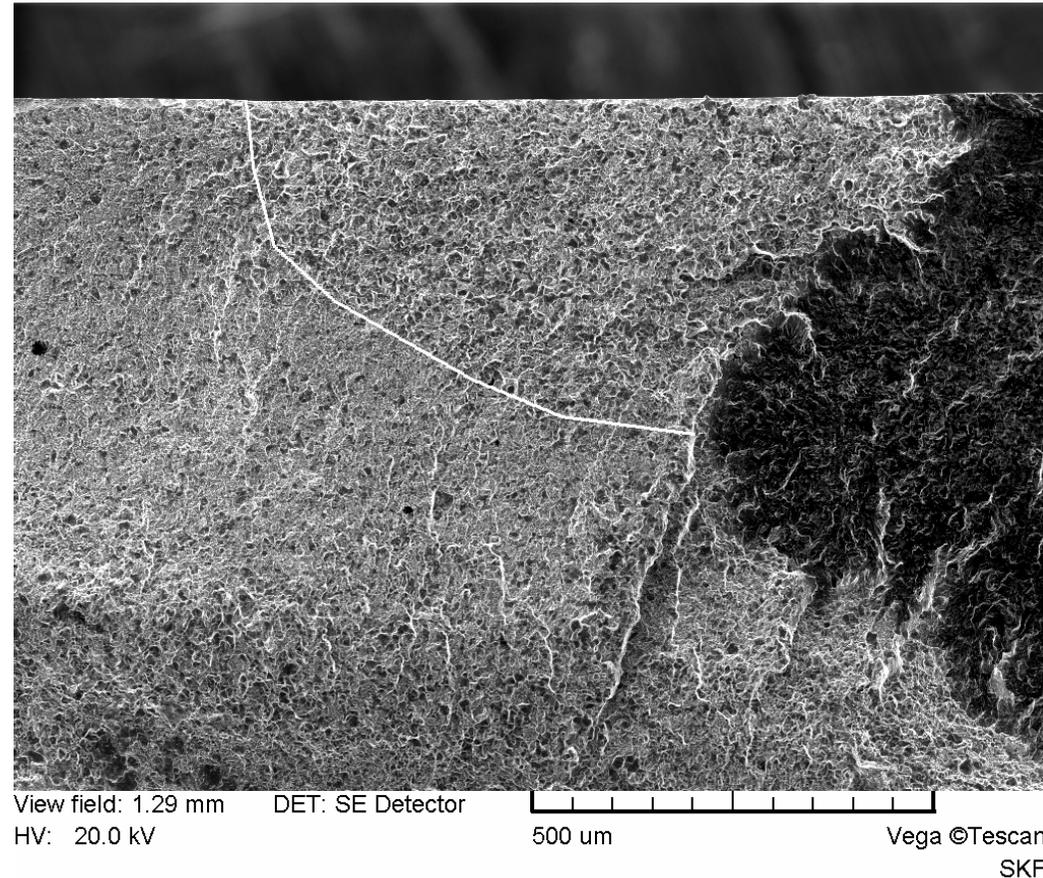
preparatively generated forced fracture face reveals local
hydrogen embrittlement adjacent to the original CFC crack
• increased intergranular fraction

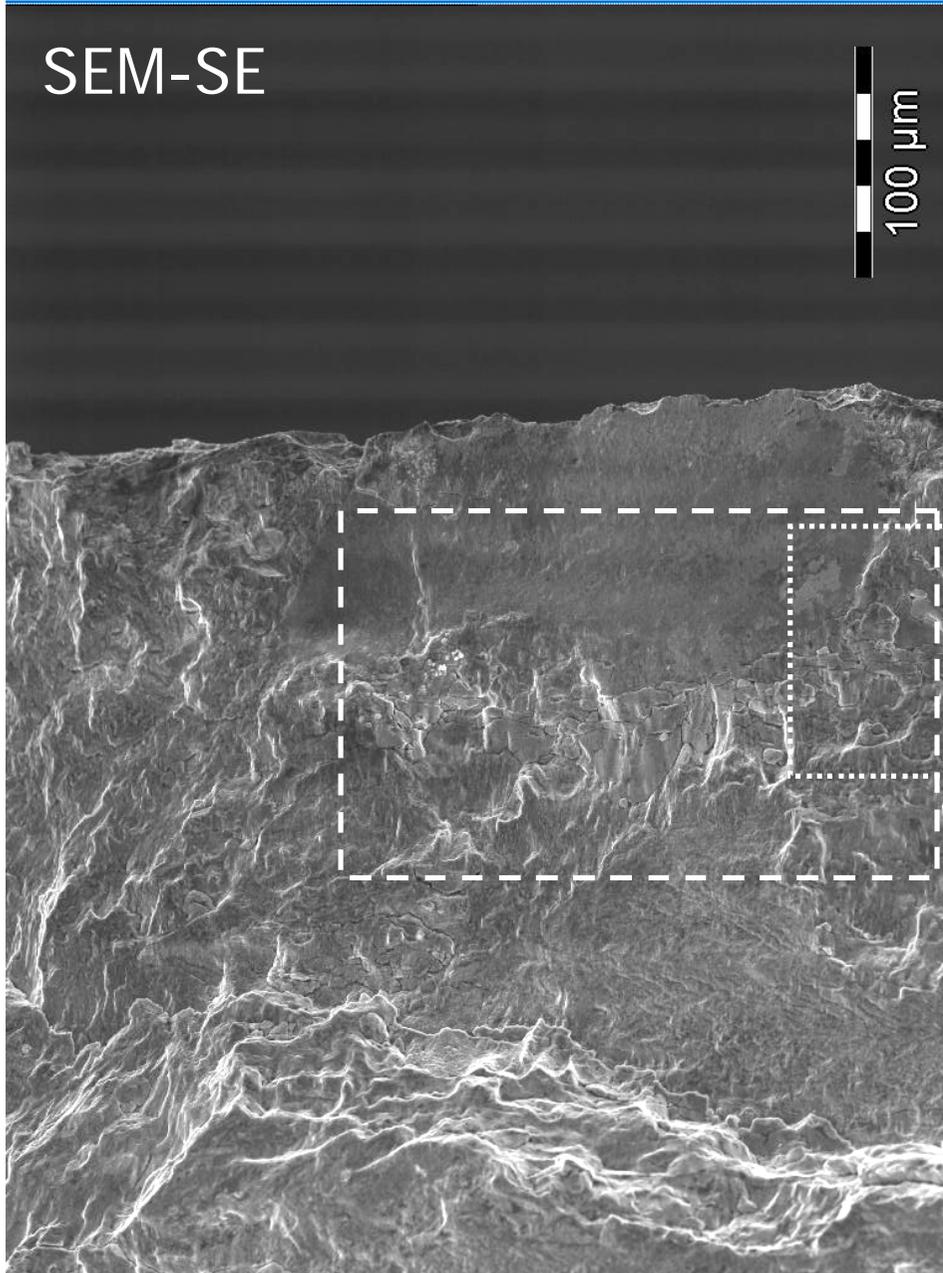
cleavage fracture
as initiation of CFC

different crack mechanisms
inside and outside the flat face

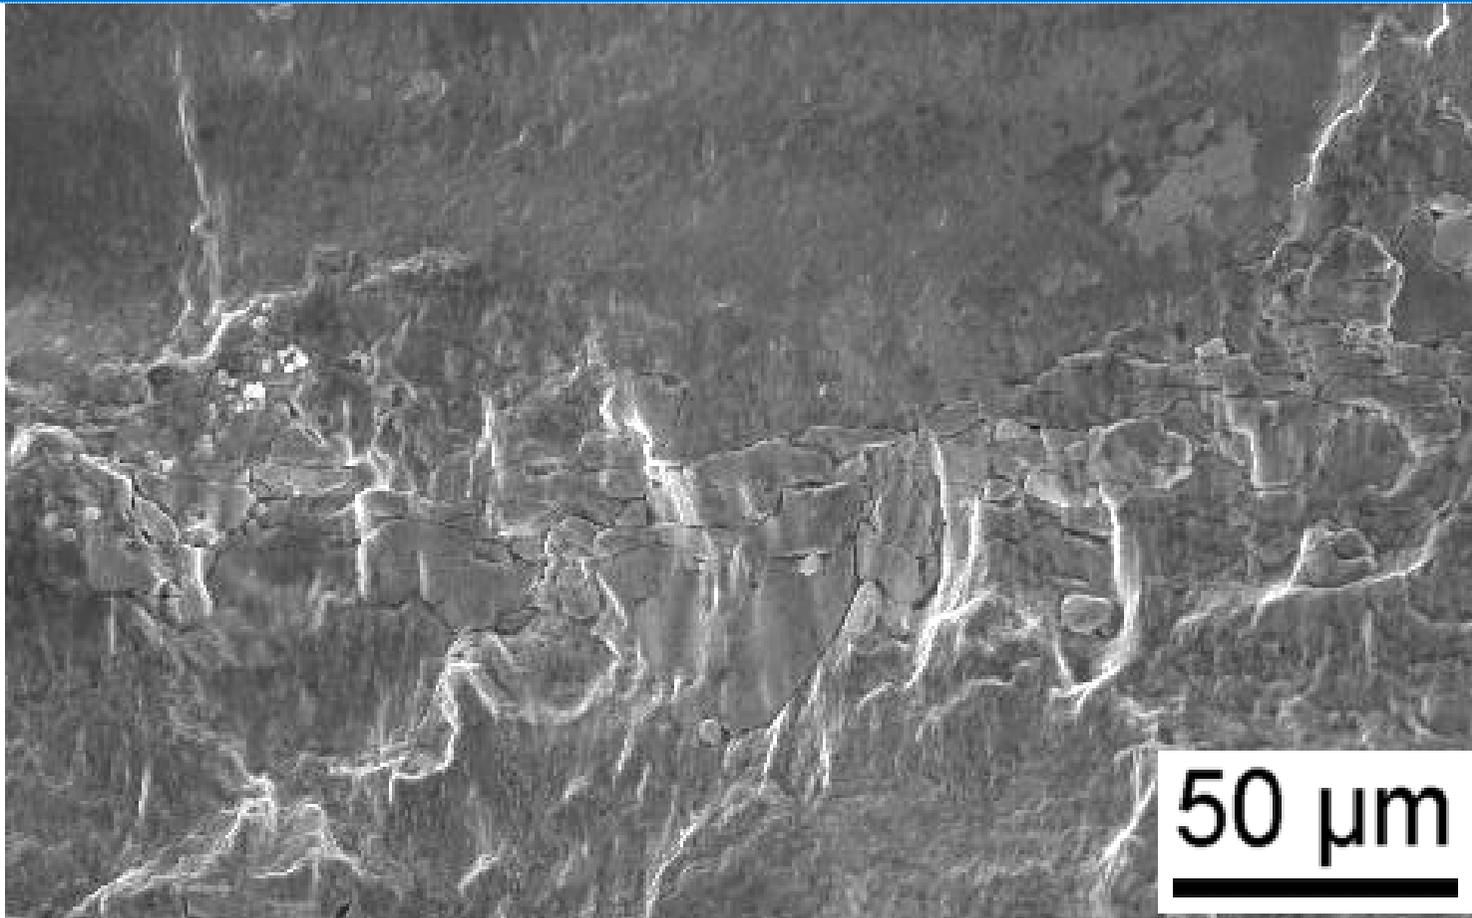
demarcating crack network at the runout of the *cleavage* fracture

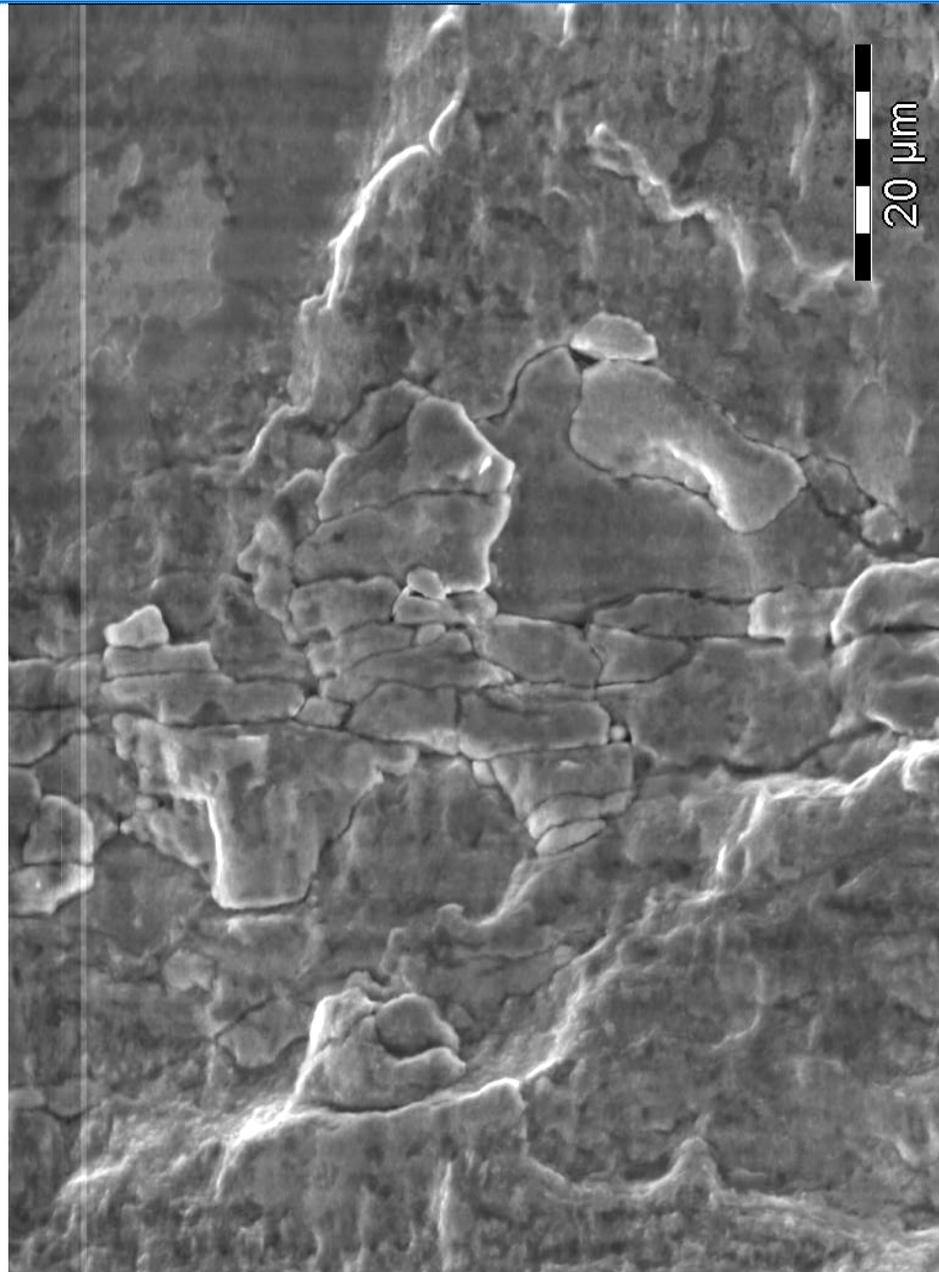
demarcating crack network

• *cleavage* crack occurs first

• temporary crack stop and gradually starting CFC

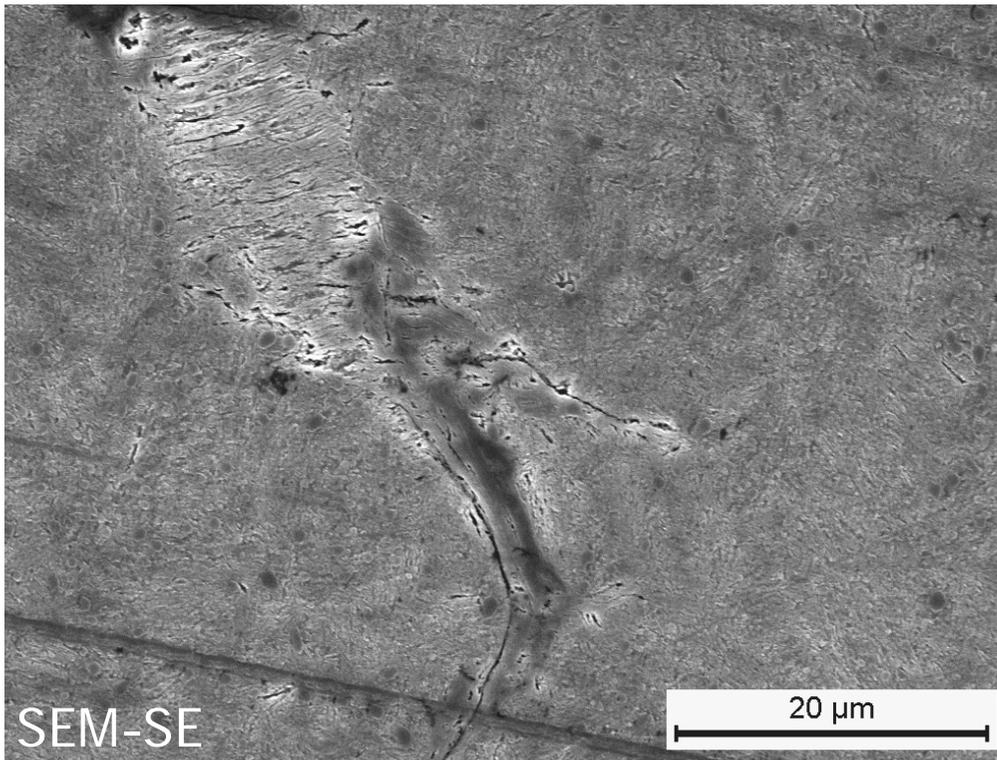
incipient phase transformation (DER)
at branching crack tip and crack face

- near CFC cracks: local DER → WEA

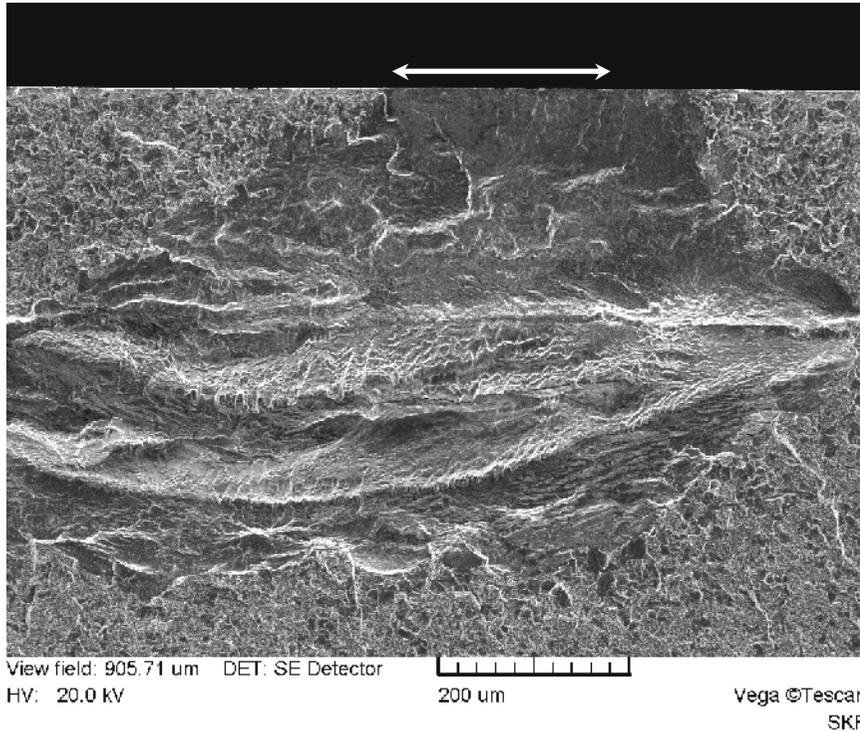
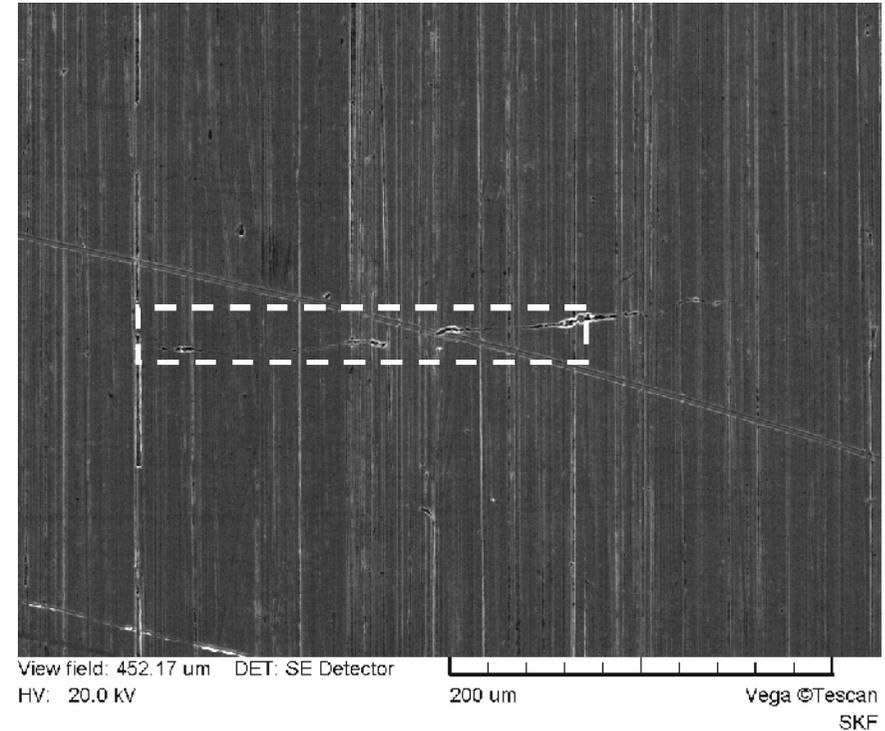
vertical semicircular *cleavage* fracture

- sharp crack edges indicate the **incipient hairline *cleavage***

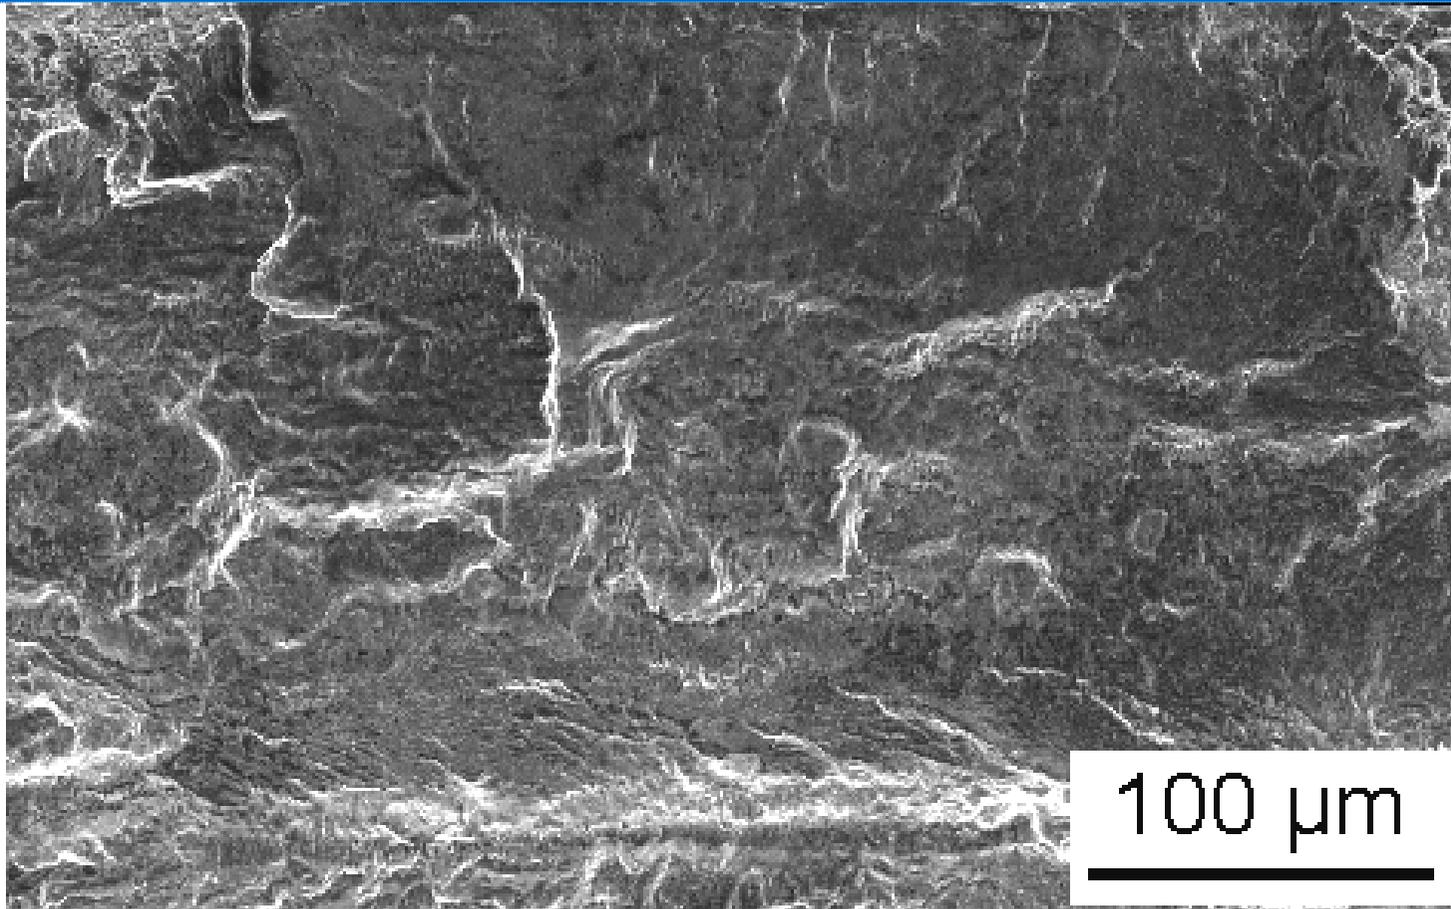
- side cracks and pores at the runout of the *cleavage* fracture

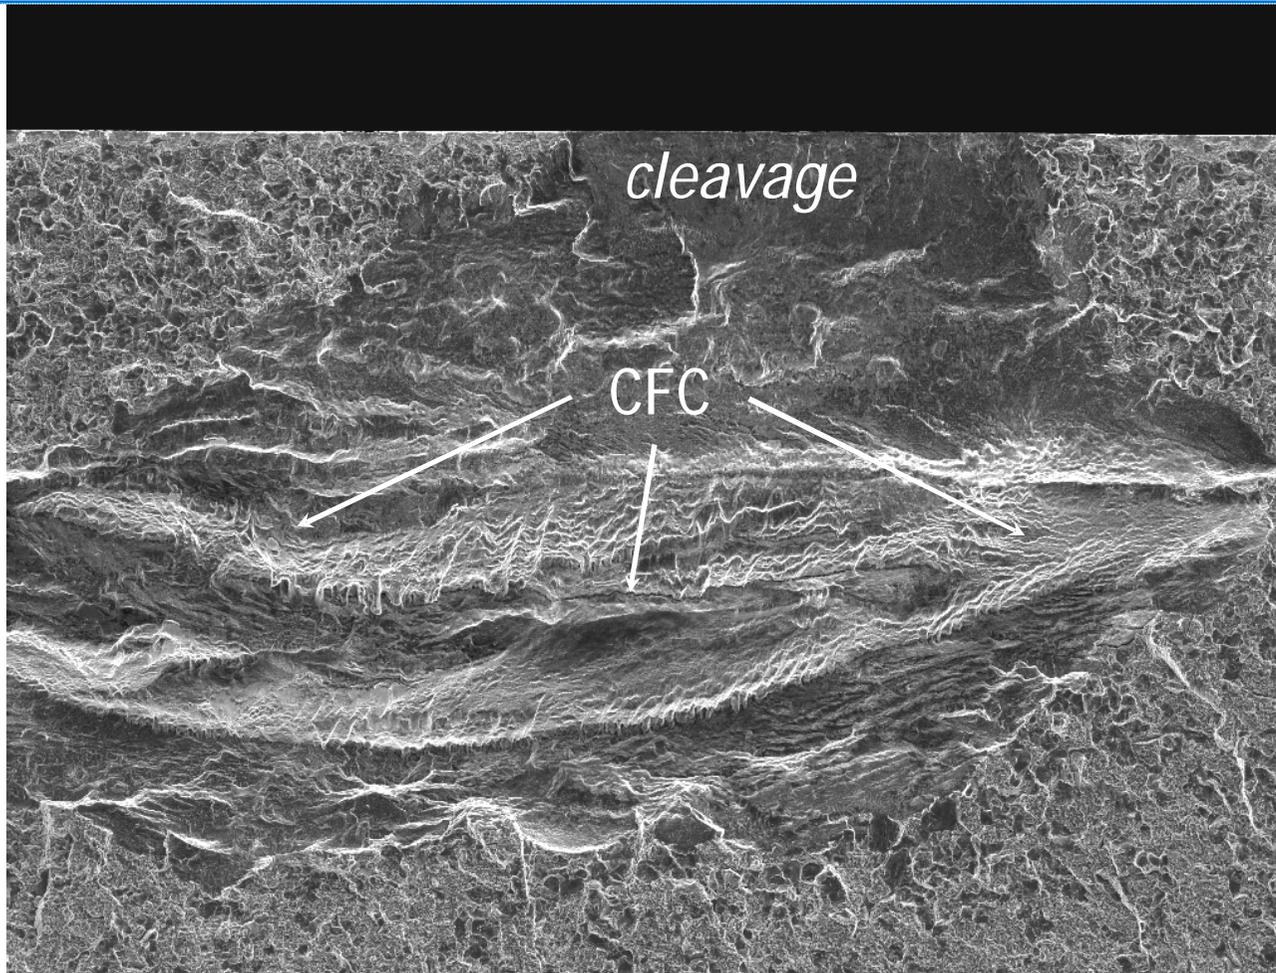
total fracture face
is transgranular

- *cleavage* fracture initiates CFC

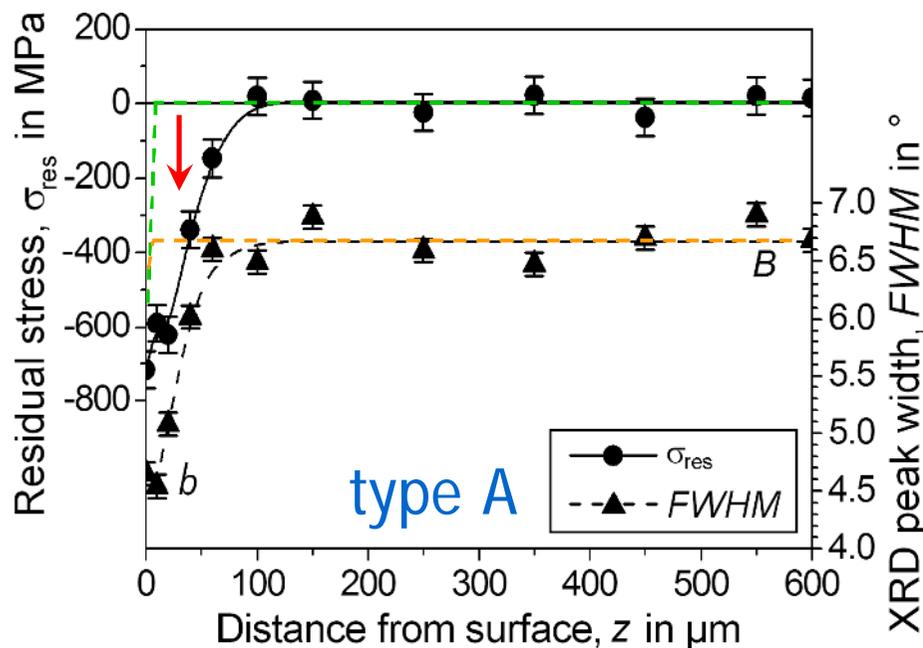
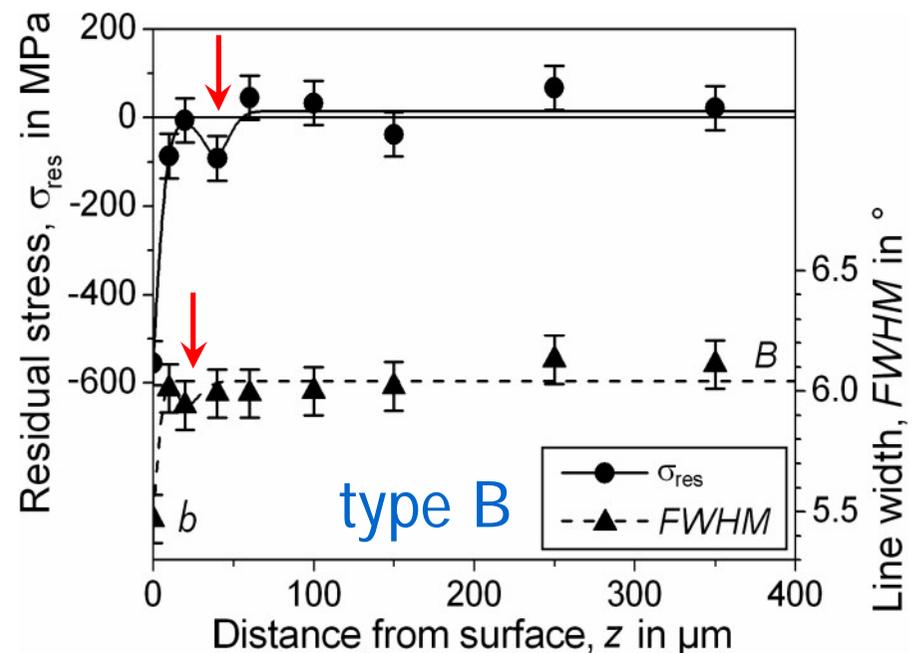
material loading by equivalent shear stresses caused by vibrations

• both types of vibration residual stress pattern occur in WEC cases

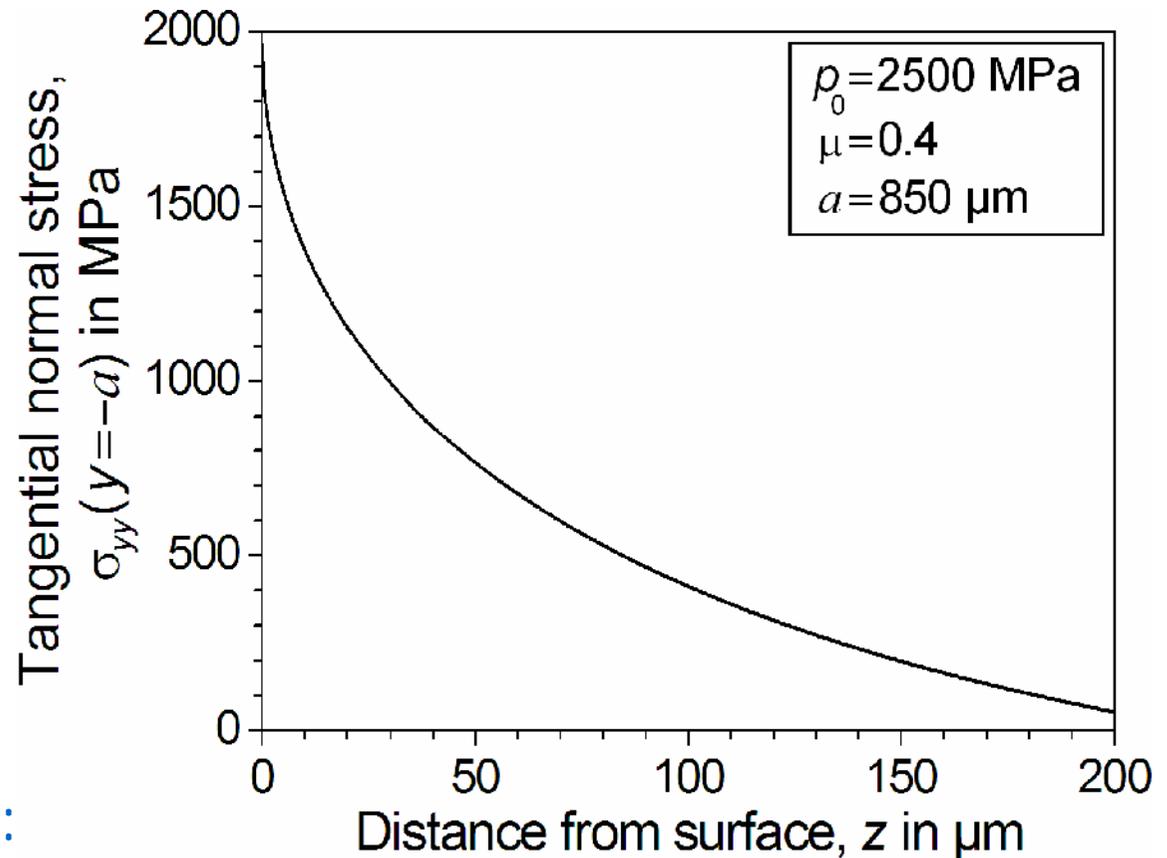
4. Normal Stress Hypothesis

Equivalent stress:

$$\sigma_e^{nsh} = \sigma_{yy}(y = -a)$$

real peak load condition:

spontaneous crack initiation

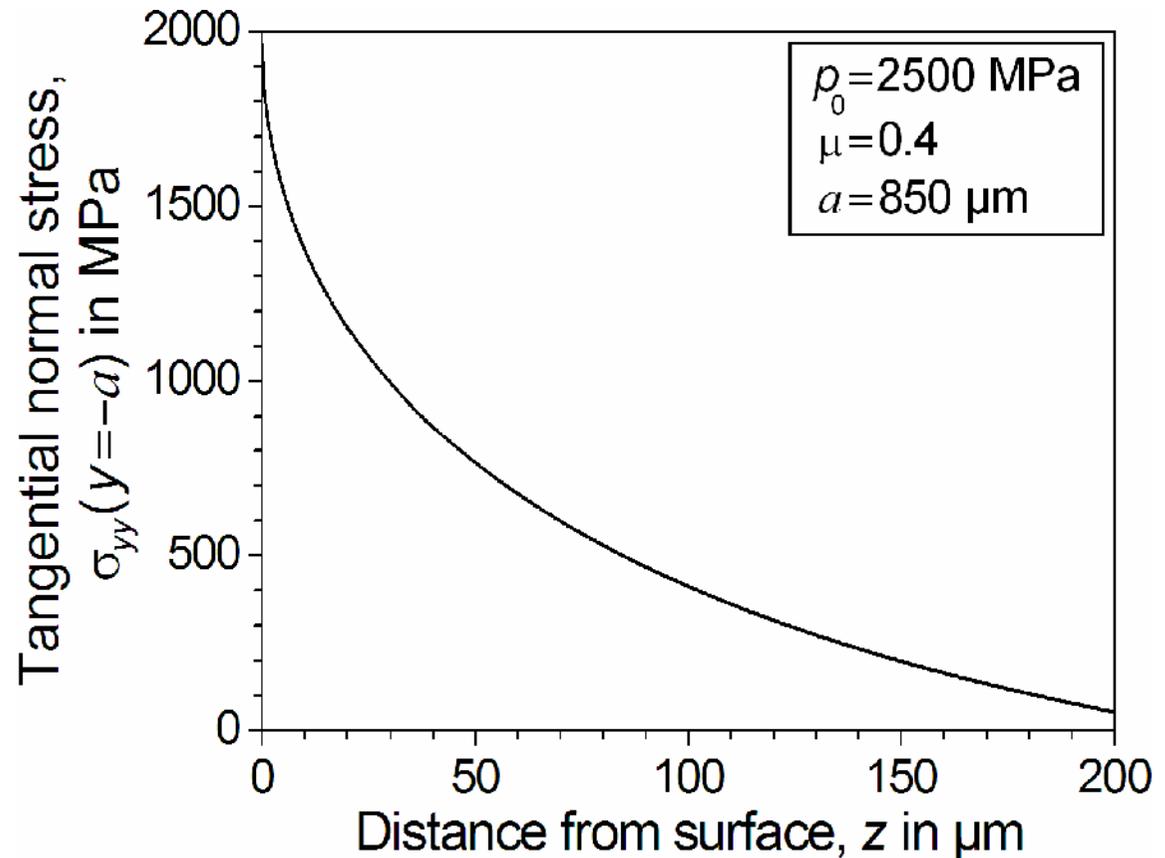
IR-TRB, wind turbine gearbox

Failure range:

$$\sigma_e^{nsh}(z) \geq \sigma_{cF}(z)$$

$\sigma_{cF}(z)$ cleavage fracture strength

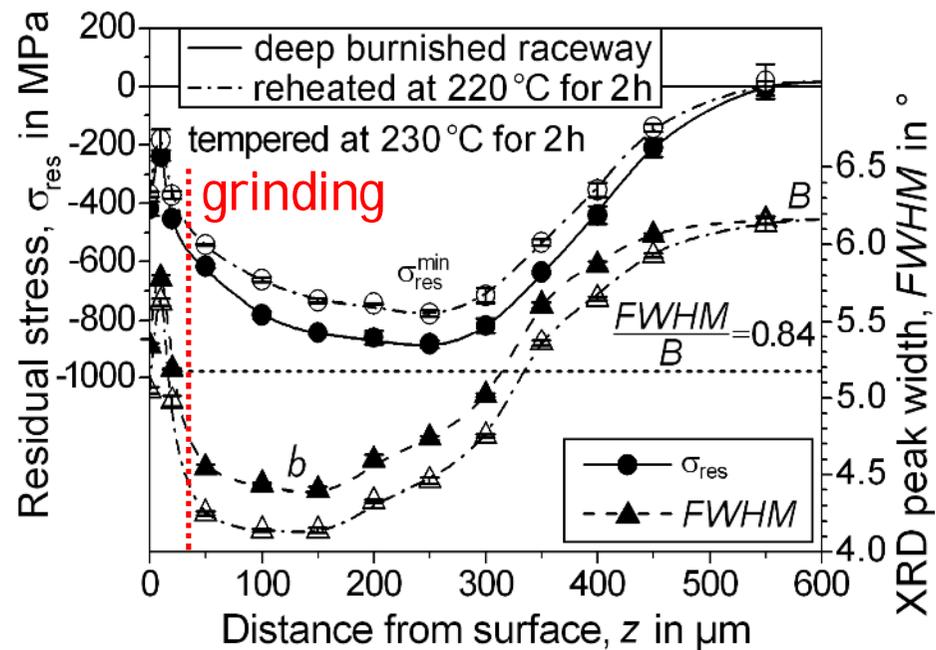
Ÿ successfully proven in mixed friction loaded rolling contact

ú *cleavage* cracks reproduced and prevented by deep rolling

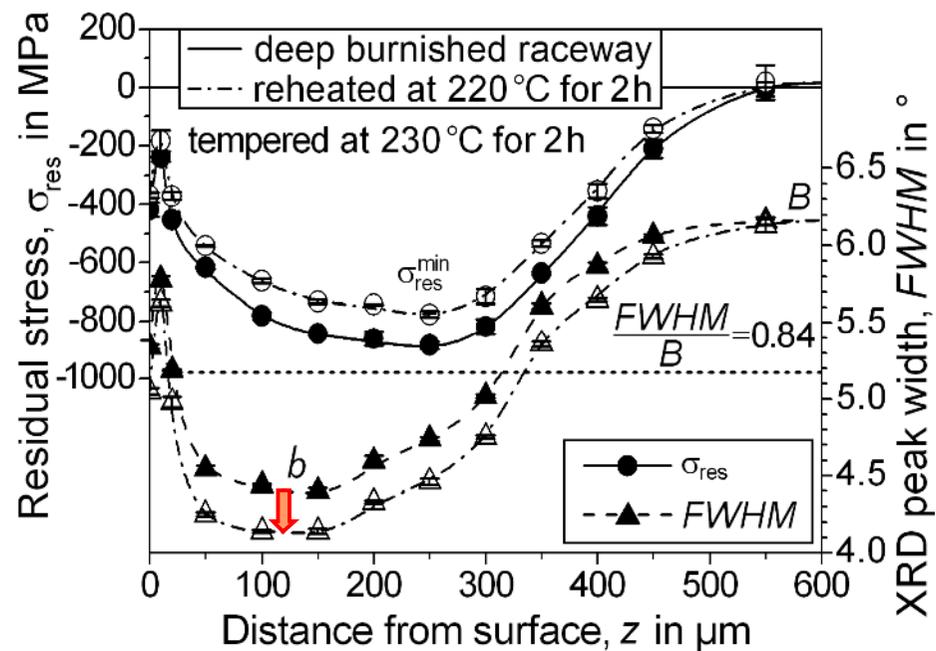
compressive residual stresses by cold working

• *cleavage* cracks reproduced and prevented by deep rolling

+ black oxidizing: reduced micro friction under peak loading

+ thermal post-treatment
